## Supporting Information

# Failure of multi-layer graphene coatings in acidic media

Feng Yu, Adam C. Stoot, P. Bøggild, Luca Camilli\*

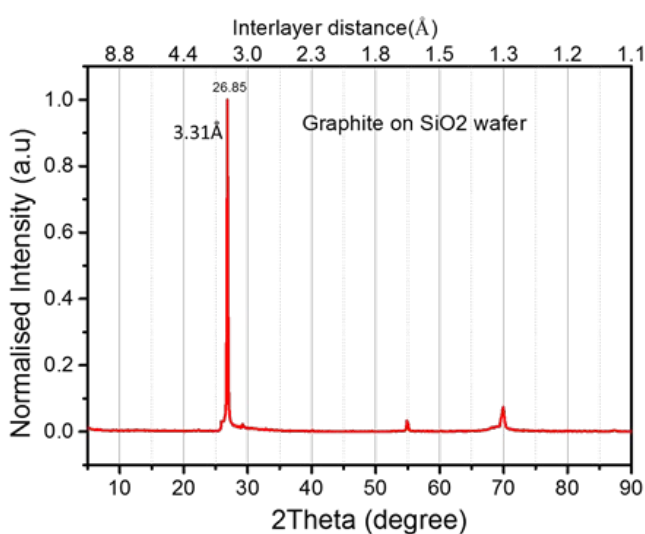
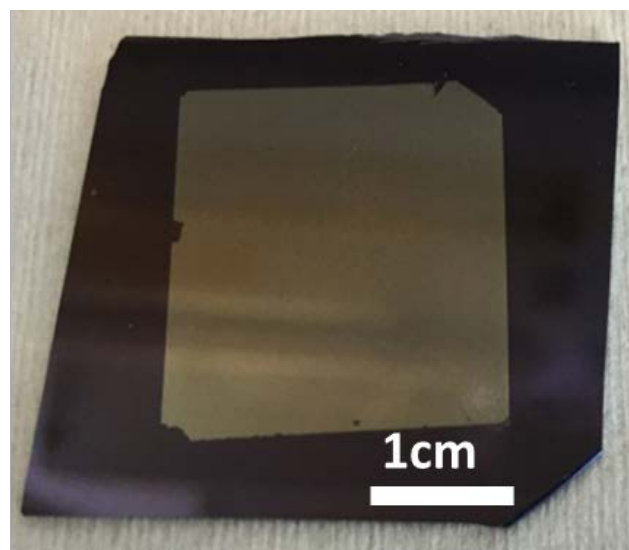
**Figure S1. (left) X-ray diffraction pattern (CuK $\alpha$  excitation source) of a multilayer graphene (MLG) film deposited on a ~88nm SiO<sub>2</sub> substrate (right). The main peak, at around 27 degree, is due to the diffraction from the (002) planes of the graphitic film and gives an average interlayer distance of 3.31 Å.**

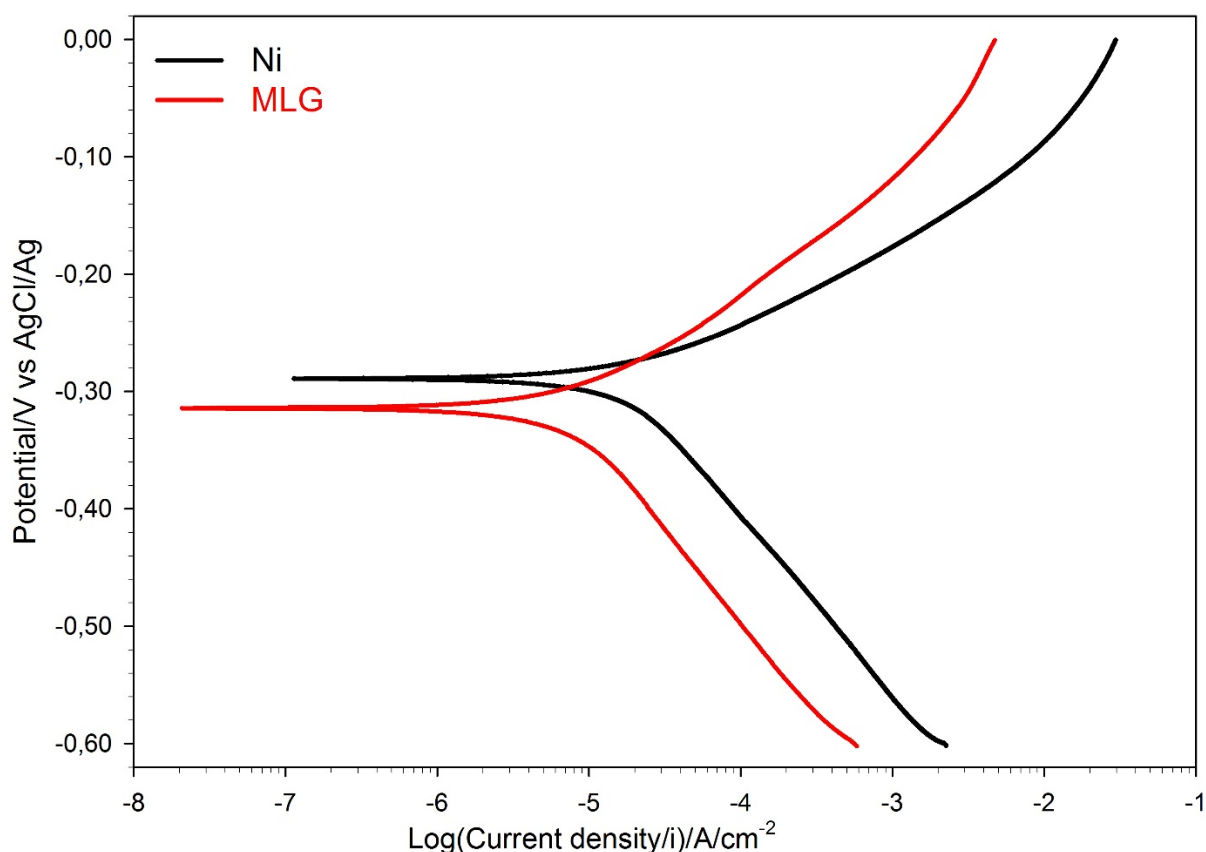
**Figure S2. Polarization scans of both bare (dark curve) and MLG-coated (red curve) Ni samples after immersion in 0.5M HCl for 1 hour.** The intersect between the extrapolation of the linear regions on both the cathodic and the anodic side of the current density minimum gives the corrosion potential (-290mV for bare nickel, -315mV for MLG-coated nickel) along with the corrosion current,  $I_{corr}$  ( $21\mu\text{A}/\text{cm}^2$  and  $9\mu\text{A}/\text{cm}^2$  for bare and MLG-coated nickel, respectively). This, in turn, can be used to estimate the corrosion rate of the two systems:  $CR = \frac{I_{corr} \cdot K \cdot EW}{\rho \cdot A}$  wherein  $K = 3272 \text{ mm/year}$ , Nickel equivalent weight ( $EW$ ) = 29g and the area is the expose working electrode area ( $A$ )<sup>1</sup>. The corrosion rates are calculated to be 0.226mm/year for bare nickel and 0.097mm/year for MLG-coated nickel.

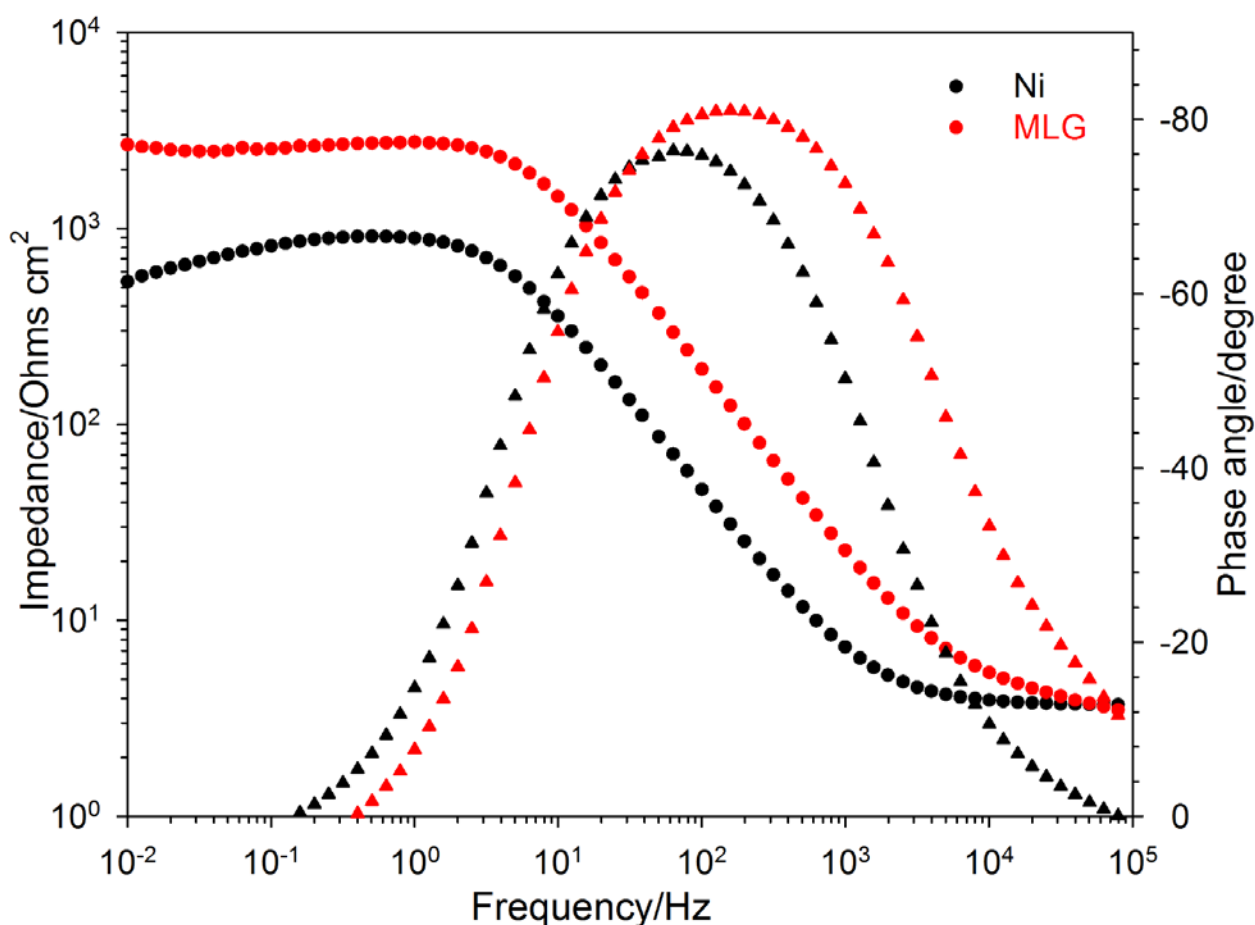
**Figure S3. Electrochemical impedance spectroscopy of both Ni (black curves) and MLG-coated Ni (red curves) after immersion in 0.5M HCl for 1 hour.** The magnitude of impedance (circles) at 10mHz for MLG-coated Ni samples is  $\sim 2700 \Omega \cdot \text{cm}^2$ , which is 5 times the value of  $\sim 540 \Omega \cdot \text{cm}^2$  for bare Ni. This further indicates that MLG-coated Ni is more corrosion resistant than bare Ni. In the case of MLG-coated Ni, in the medium frequency region (10-1000Hz), both a shift to higher values of impedance (circles) and a shift to higher frequencies of time constant (triangles) can be observed when compared with bare Ni (with the time constant being the frequency where phase angle reaches the highest value on phase diagram). These features suggest that the double layer capacitance on MLG-coated Ni is lower than that of bare Ni, indicating that, to some extent, the MLG coating is acting as a barrier.

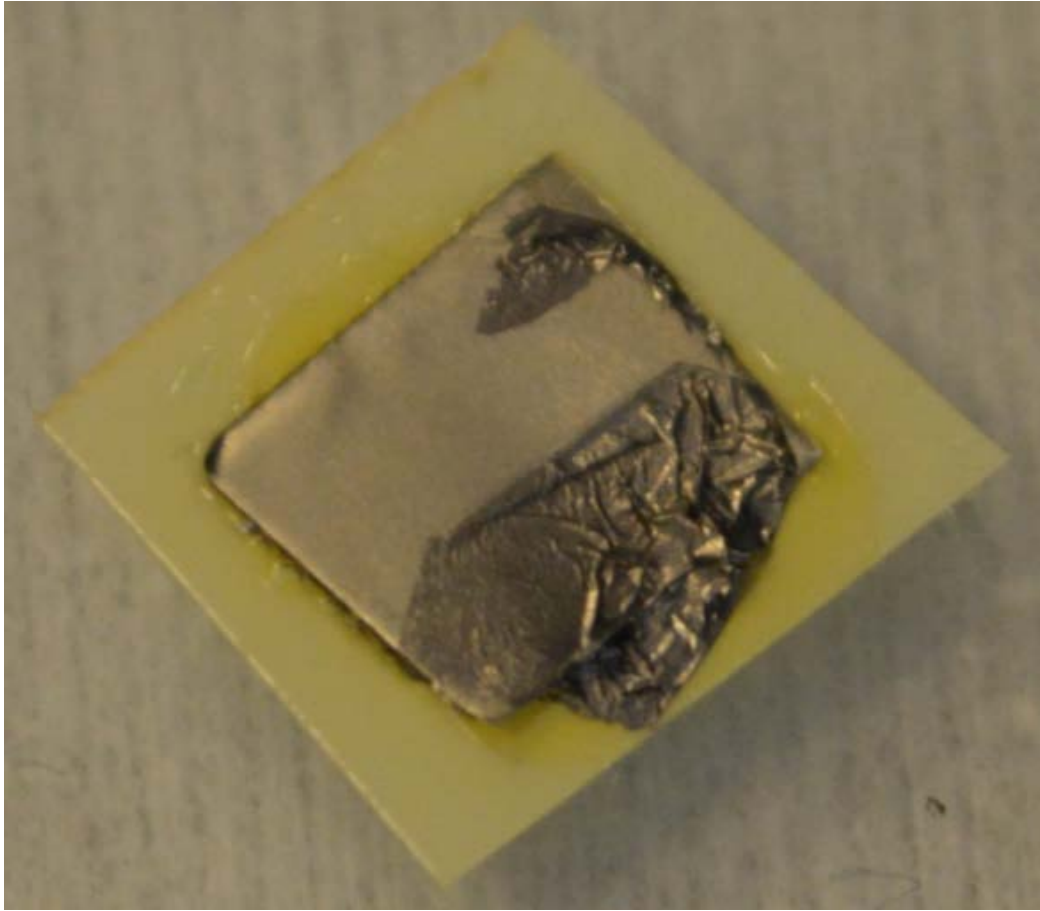
**Figure S4. Delamination of the MLG coating from nickel substrate.** A drop of 0.5M HCl solution was placed on a MLG-coated Ni sample, covering the whole surface. After 18 hours, the acid was removed by carefully absorbing it with a tissue, without touching the MLG coating. As can be seen from the picture, nearly the whole MLG film was delaminated from the nickel substrate due to the hydrogen bubbles formed at the MLG and Ni interface, with subsequent loss of adhesion of the coating.

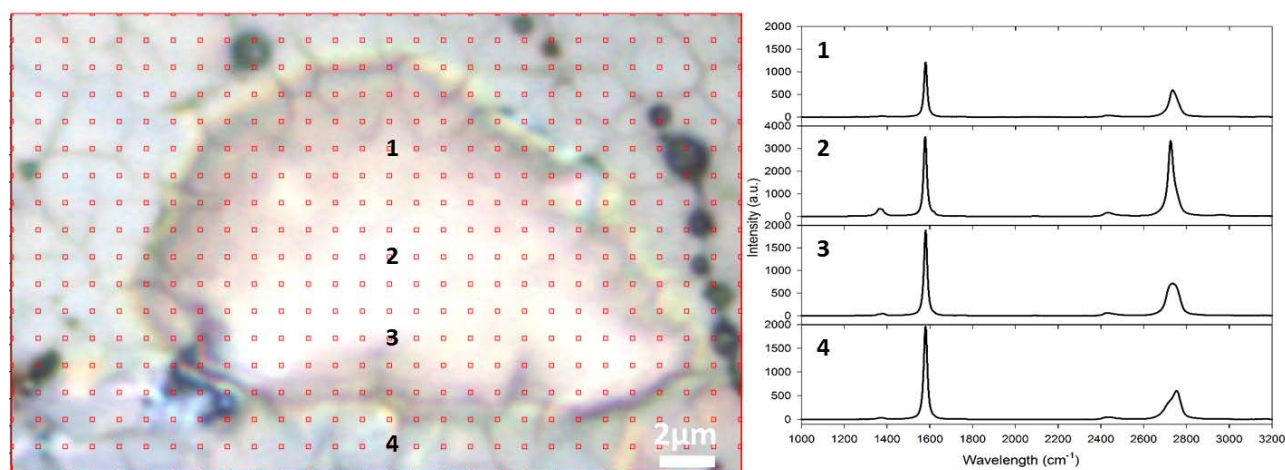
**Figure S5. (left) Optical image and (right) Raman spectra of a blister formed under the MLG film.** MLG-coated Ni sample was immersed in 0.5M HCl with an applied potential of -0.6V (vs. AgCl/Ag reference electrode) for 3min. Then, one of the blisters, which were found at the interface between MLG coating and nickel substrate, was analysed by Raman spectroscopy. The Raman spectra taken at different spots on top of the blister (point 1, 2 and 3) and outside (point 4) indicate the absence of any remarkable shift in the graphene peaks.

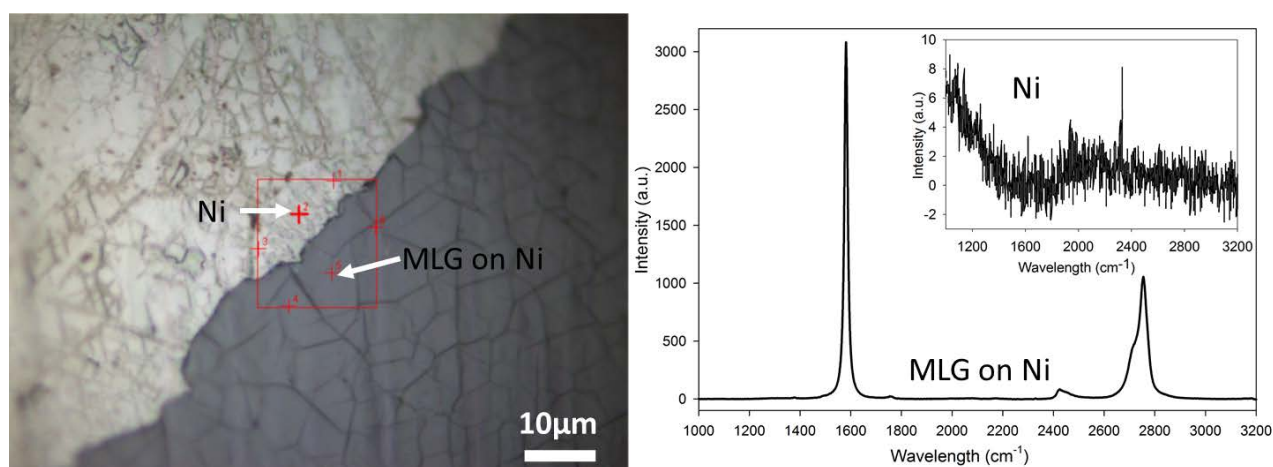
**Figure S6. (left) Optical image and (right) Raman spectra of an area of the coated nickel sample where the MLG coating was partially delaminated.** MLG-coated Ni sample was immersed in 0.5M HCl with an applied potential of -0.6V (vs. AgCl/Ag reference electrode) for 30min. The MLG coating was thus locally delaminated, showing some areas with no coating (left). The absence of the coating in this area is also proved by Raman spectroscopy (right).

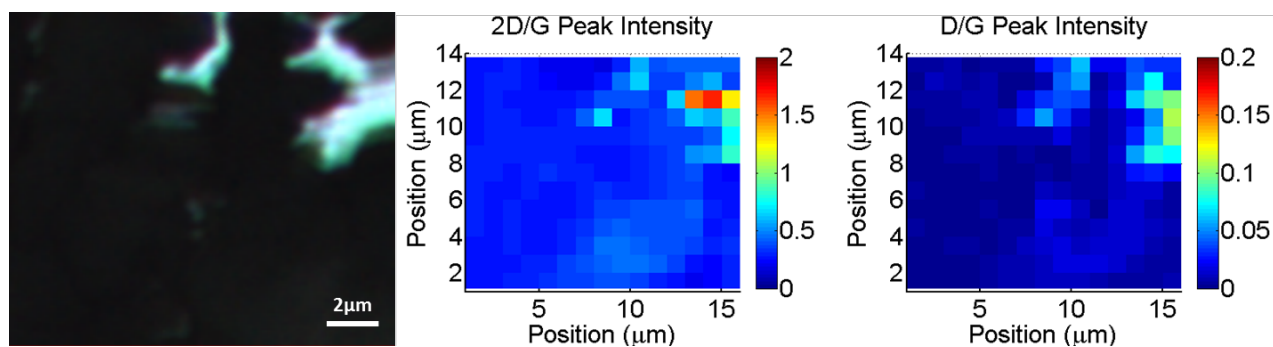
**Figure S7. Optical image (left) with back illumination and relative Raman map (2D/G, at centre, and D/G, at right) of a transferred MLG film on a glass slide.** The MLG is transferred on a glass slide and placed inside the Raman microscope. Back illumination is used to pinpoint the location of inhomogeneities in the MLG film (displayed as bright spots in the optical image at left). Raman map is then used to investigate the MLG film. The bright features found in the optical images show a higher defect density (see the D/G map, right panel) and a fewer number of layers (see 2D/G map, centre panel) with respect to the rest of the MLG film. These inhomogeneities are thought to be weak points in the coating and during the electrochemical tests they create paths for the acid, which can reach the nickel surface thus producing hydrogen.

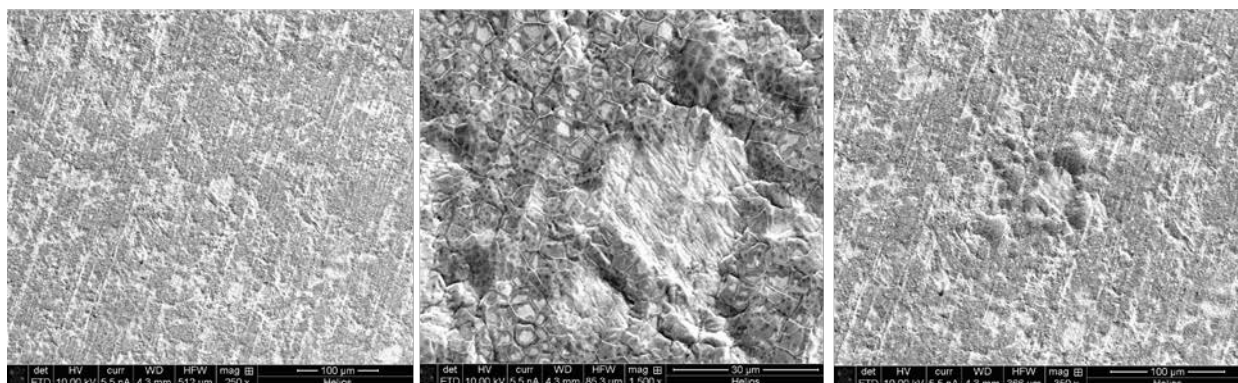
**Figure S8. In-situ evolution of hydrogen in SEM.** A droplet of 0.5 M HCl solution is placed in the centre of a MLG-coated nickel foil, and gently removed with a tissue. The sample is then mounted inside a SEM without prior rinsing or blow-drying. When the electron beam is focused on a flat region of the sample (left panel), some hydrogen bubbles are generated under the MLG coating (centre panel). At lower magnification, it is possible to see that the blister-like protrusions in the coating are mainly found in the area that was initially irradiated by the scanning electron beam (right panel).
