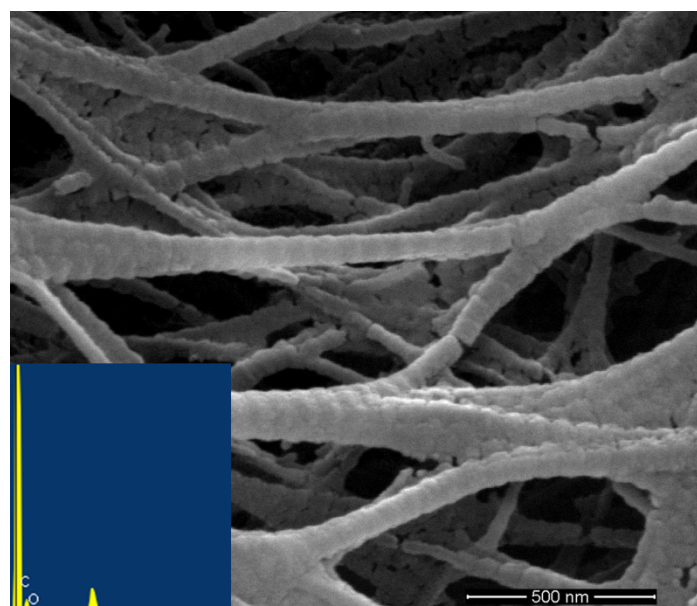
Figure S1. SEM image of the dentin surface after being demineralized with 37% phosphoric acid for 2 min. Energy disperse spectrum (EDS) (Insets) showed that there were no Ca and P elements on the demineralized surface.
