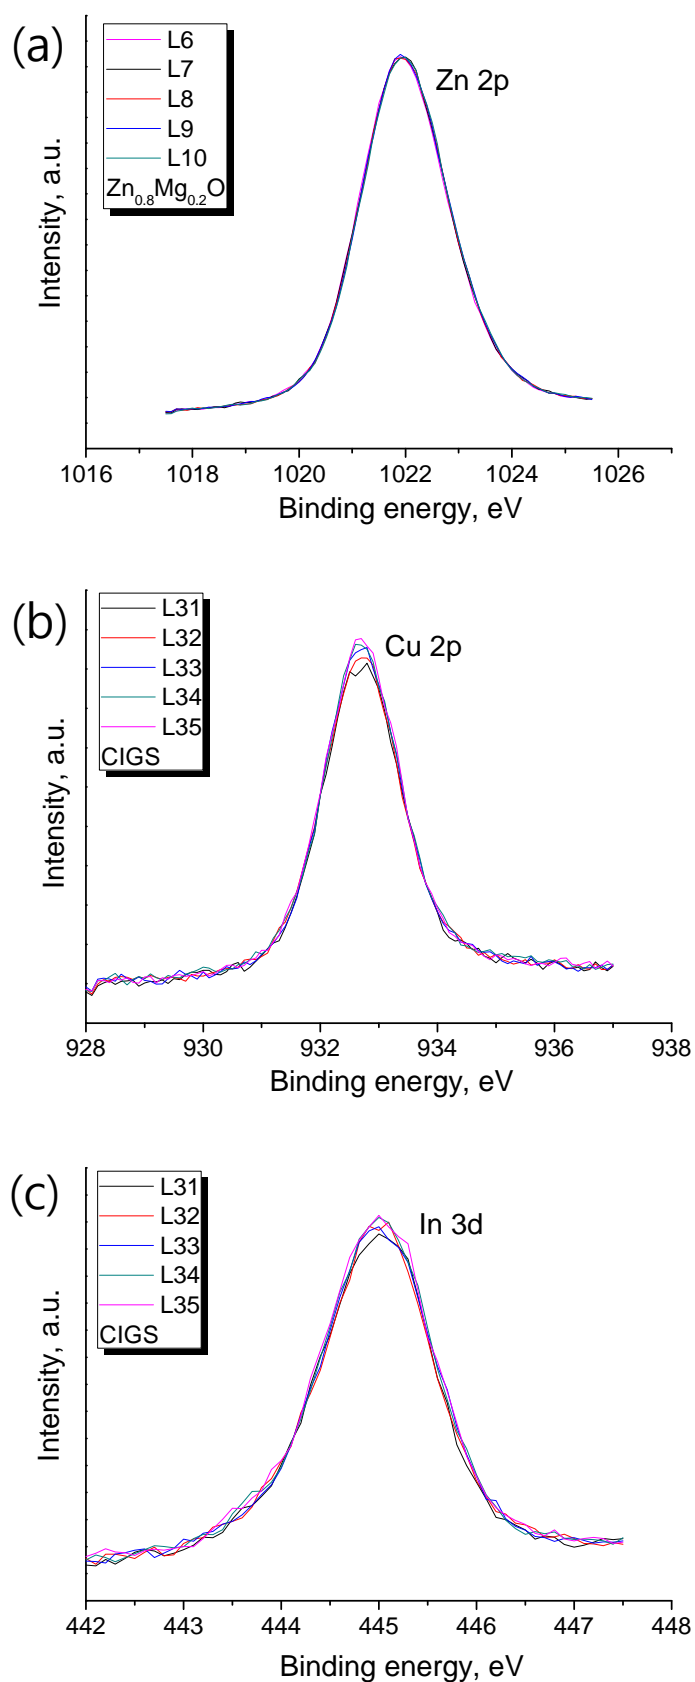
Figure S1. XPS peaks for (a) Zn 2p (L6-10), (b) Cu 2p (L31-35), and (c) In 3d (L31-35) core levels from the bulk $\text{Zn}_{0.8}\text{Mg}_{0.2}\text{O}$ region and bulk CIGS region. No change of peak positions and their FWHM values indicates that there is no sample damage during sputter etching.
