Supplementary Information

1. Details about ash deposition probe

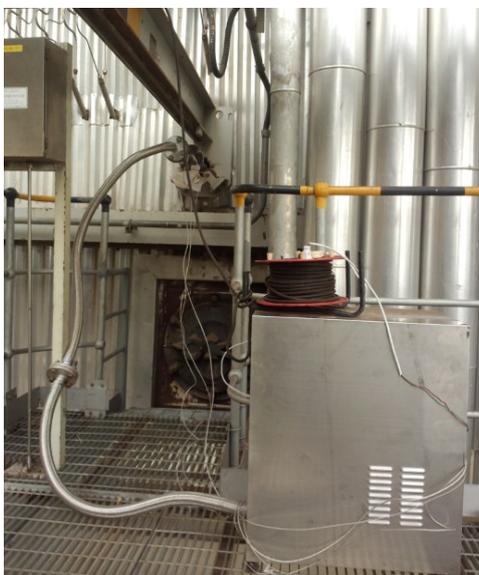
Fig. 1 the temperature-controlled ash deposition probe

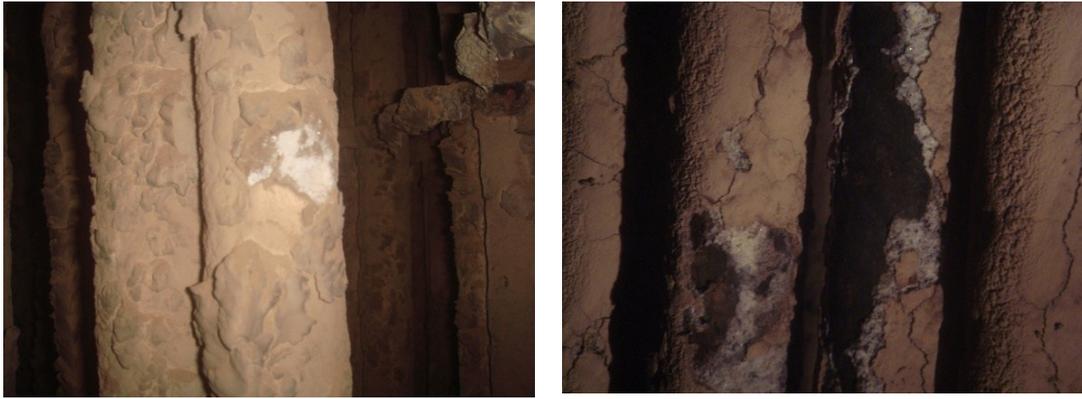
During boiler maintenance, the mature deposits were derived directly from the high-temperature superheater. As shown in Fig. 4, the surface of the deposits showed obvious signs of erosion. And the interior contained a large amount of white crystal salt [both in Fig. 4(a) and (b)], which was tested as KCl. After stripping the deposits from the superheater, in Fig. 4(b), obvious corrosion traces could be found on the surface of tubes, which were dark brown.

(a) deposits and white crystal salt

(b) deposits and corrosion on the tube surface

Fig. 4 mature deposits on the high-temperature superheater
