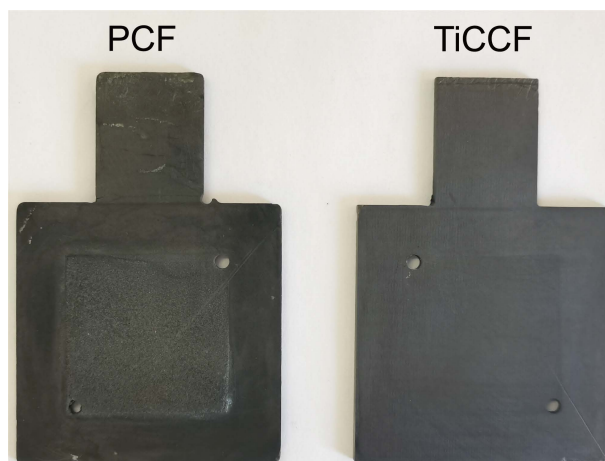
**Fig. S27 Comparison of corrosion of graphite plates at the positive side of (a) PCF and (b) TiCCF electrodes after cycling at  $80 \text{ mA cm}^{-2}$  when without MEPBr.**
