Appendix

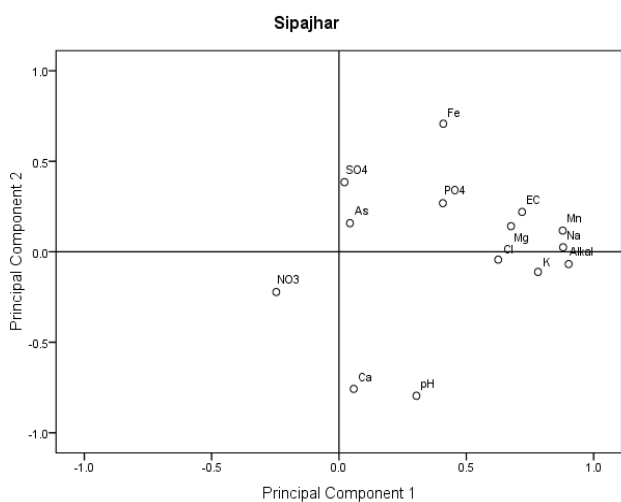
Fig. A.1 PCA plots of groundwater quality parameters at Sipajhar site of Darrang district.

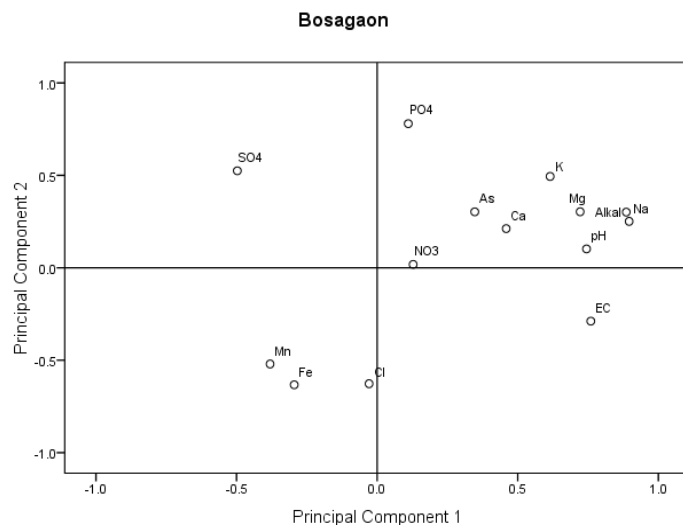
Fig. A.3 PCA plots of groundwater quality parameters in Site_3.

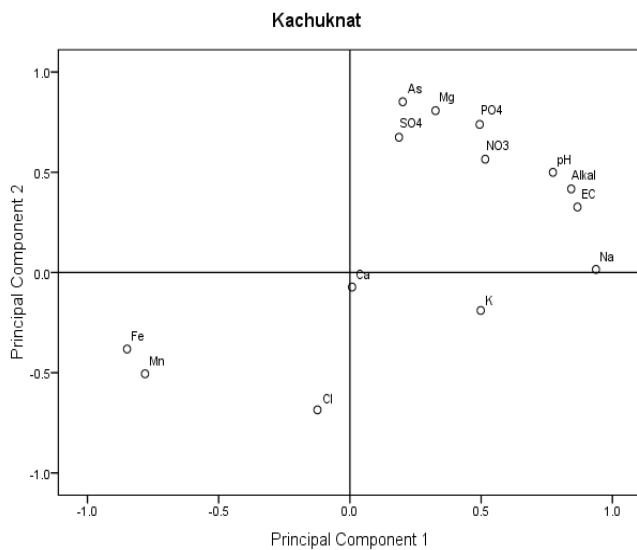
Fig. A.2 PCA plots of groundwater quality parameters in Site_2.
