Supplementary Information

S1. Set-up used for operando X-ray imaging of 18650 cell failure

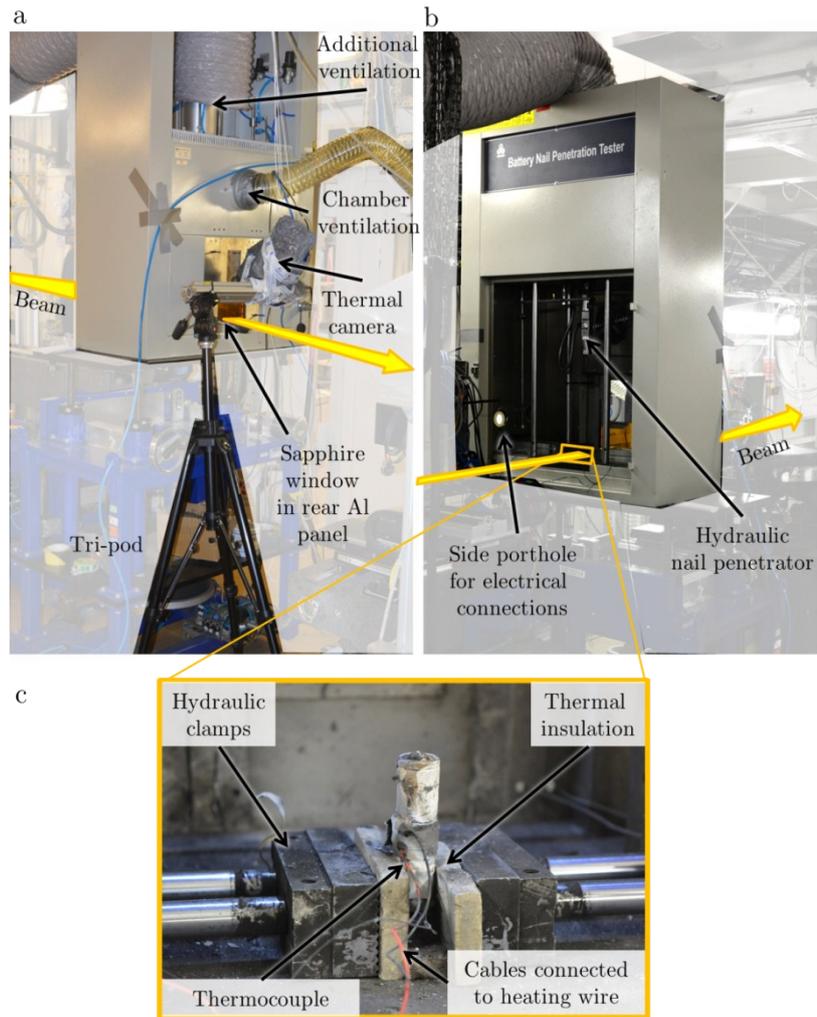
Figure S1. (a) Rear view of the nail penetration system showing the placement of the rear Al panel with an integrated sapphire window, the thermal camera, and ventilation pipes. (b) Front view of the nail penetration system (without the X-ray transparent Al front panel), showing the location of the battery being tested and hydraulic penetration piston. (c) Magnified view of inside of the penetration system showing a failed 18650 battery secured in place by hydraulic clamps and insulation plates.

The experiments performed at the ESRF beamline ID19 and Diamond Light Source beamline I12 involved high-speed radiography only, and not computed tomography. Therefore, rotational compatibility was not needed. A commercial battery nail penetration system (MTI Nail Penetration Tester, MSK-800-TE9002, MTI, Richmond, CA, USA) was modified to provide X-ray and infrared transparent windows for simultaneous thermal and high-speed X-ray imaging (Figure S1). The front and rear doors of the nail penetration system were replaced with 2 mm thick aluminium panels that had integrated infra-red transparent sapphire windows (2 mm thick), and X-ray transparent Kapton windows for simultaneous thermal imaging and radiography. The entire penetration system was mounted onto a heavy duty electronically controlled sample stage that, while under load (*ca.* 120 kg), could move in the vertical direction only at ESRF, and both the vertical and horizontal planes in Diamond Light Source. To extract the harmful gases generated during thermal runaway, the nail penetration system was connected to the beamline ventilation system via flexi-piping, and an additional wider ventilation pipe was placed over the top of the system to help exhaust escaping gases (Figure S1a,b).

During imaging, the lithium-ion batteries were held firmly in place by hydraulic clamps, which along with the penetration piston, was connected to a 3 bar air supply (Figure S1b,c). The thermal camera was mounted directly above the field of view of the beam, at a slight angle facing down at the cell being tested and was shielded against the high energy X-ray by a lead cover (Figure S1a). Electrical connections for voltage monitoring and heating were passed through a side porthole (Figure S1b), and all electrical equipment (penetration system, thermal camera, heating elements and power supplies) were extended and controlled from outside the hutch in the user control room.
