## SUPPORTING INFORMATION

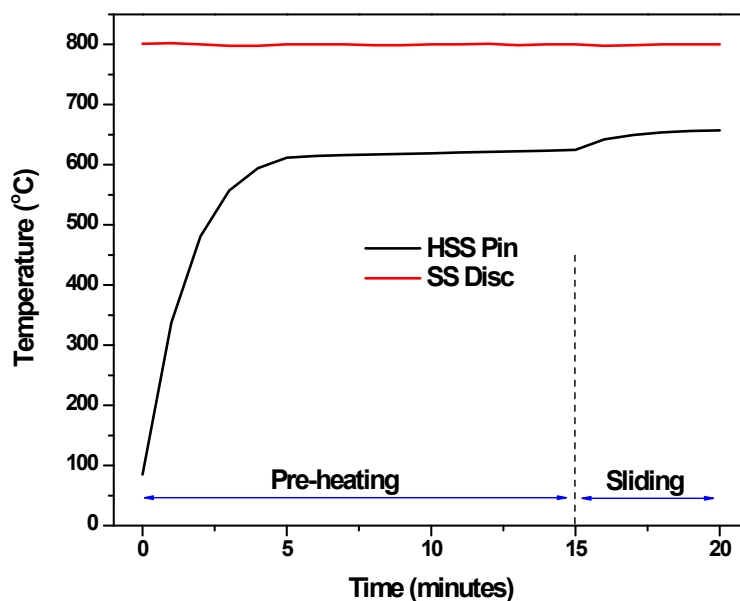
**Figure S1:** Temperature evolution of steel tribopair during pre-heating and sliding stage
