Supplementary material

Unraveling the Role of Si and Al Impurities in Ni/YSZ Fuel Electrode Degradation in Solid Oxide Electrolysis Cells

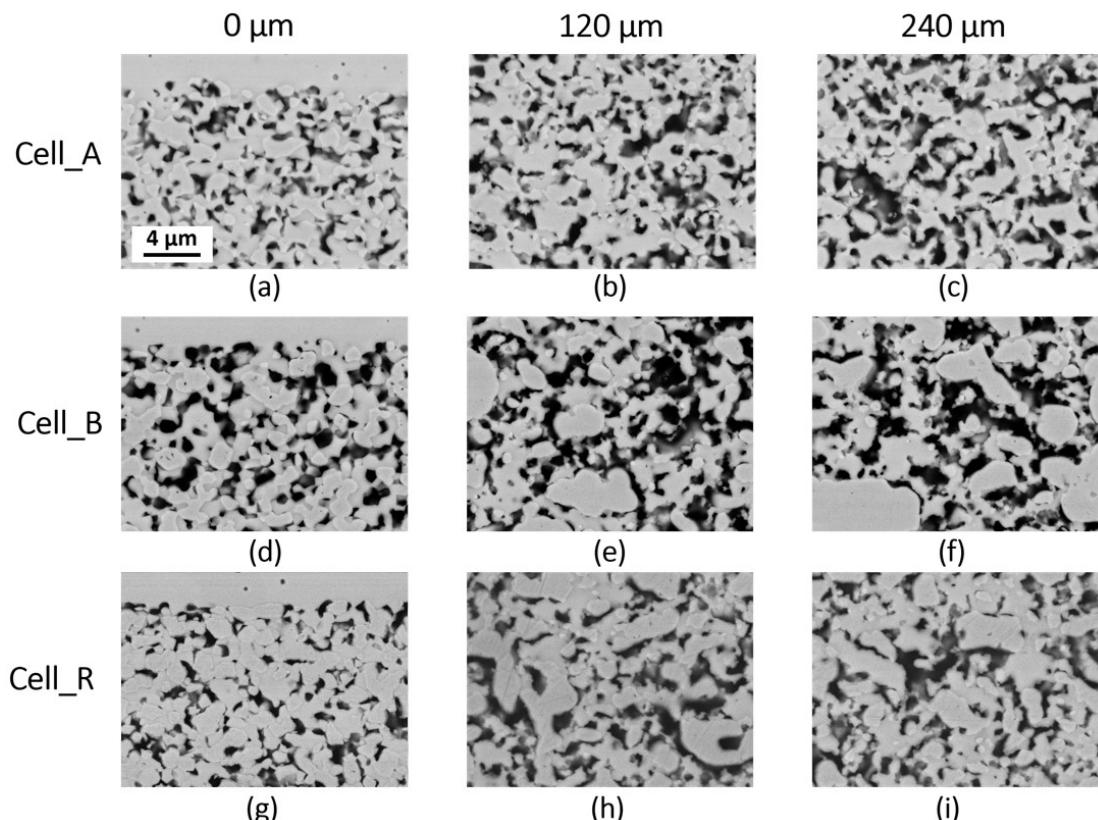
Figure S1. The SEM micrographs of the cross section of (a)-(c) Cell_A, (d)-(f) Cell_B and (g)-(i) Cell_R. All the images were taken at the gas-inlet side of the cells. The locations of the SEM images were recorded at different distance from the electrolyte/electrode interface in fuel electrode: (a, d, g) 0 μm, (b, e, h) 120 μm, and (c, f, i) 240 μm.

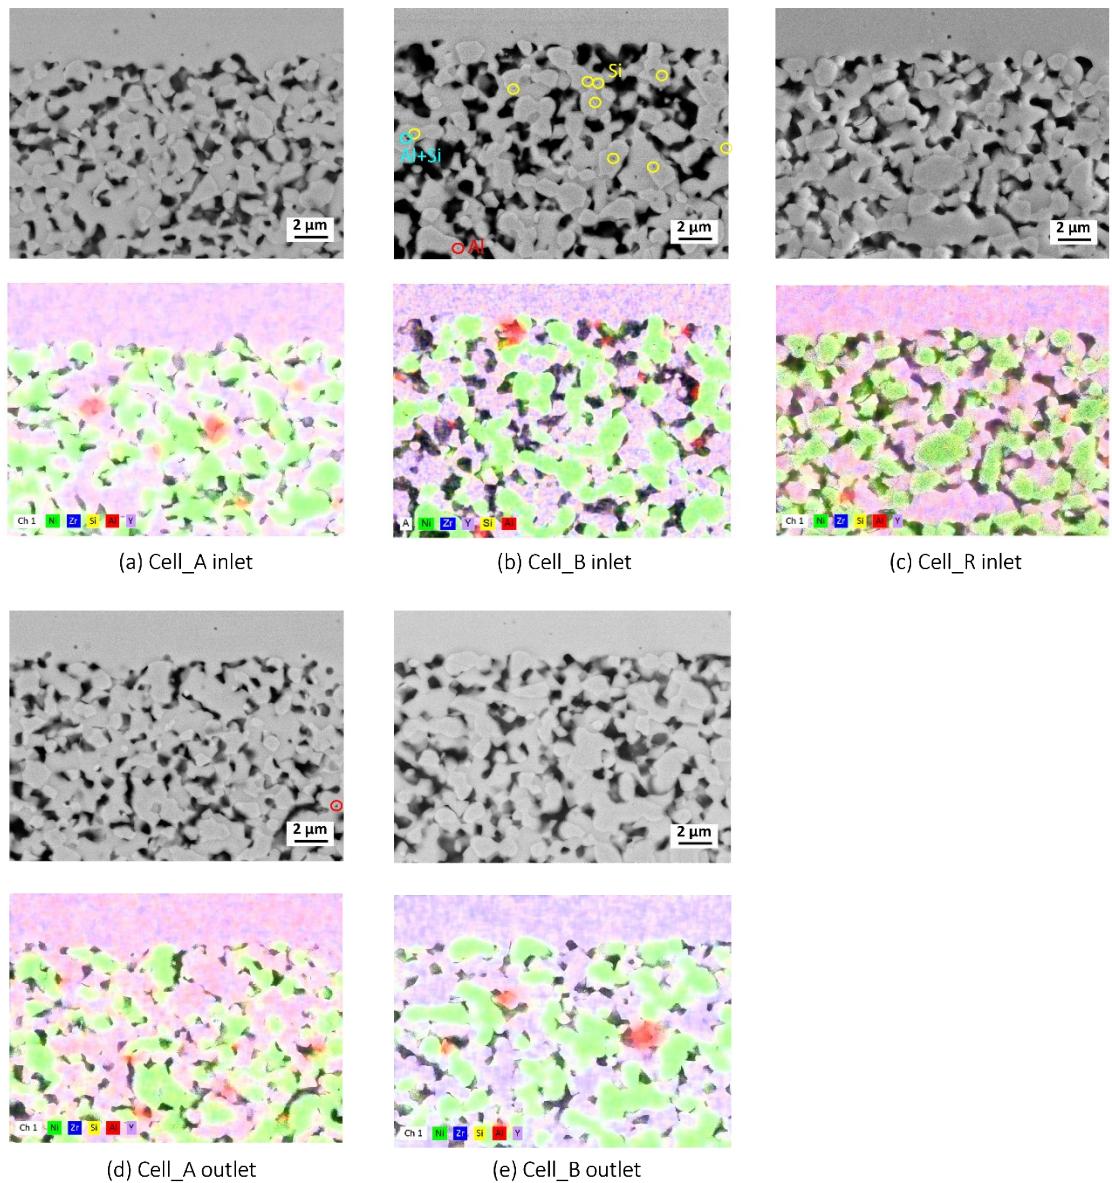
Figure S2. The SEM micrographs, mapping and point analysis of the cross section of Cell_A, Cell_B and Cell_R at gas inlet and outlet. The locations of the SEM images were recorded at the fuel electrode/electrolyte interface.

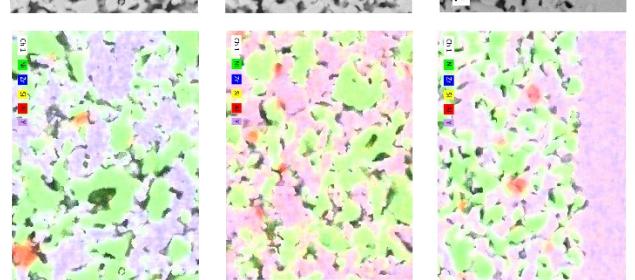
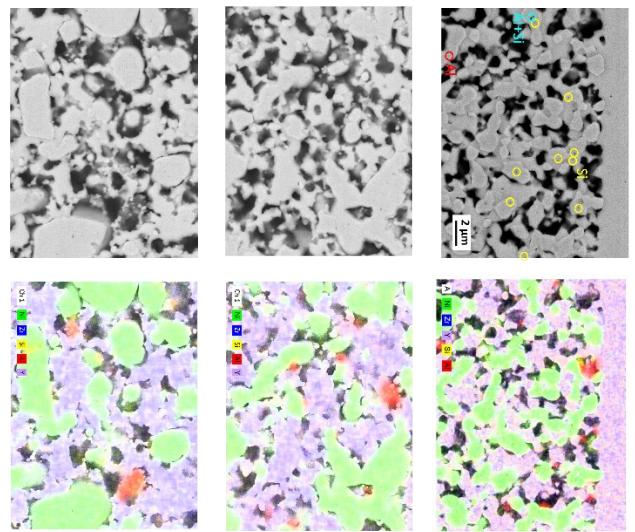
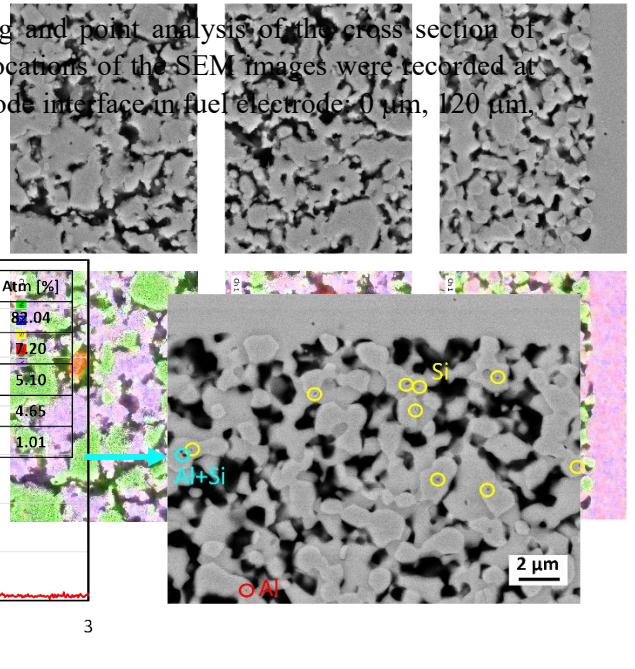
Figure S3. The SEM micrographs, mapping and point analysis of the cross section of Cell_A, Cell_B and Cell_R gas inlet. The locations of the SEM images were recorded at different distance from the electrolyte/electrode interface in fuel electrode: 0 μ m, 120 μ m, and 240 μ m.

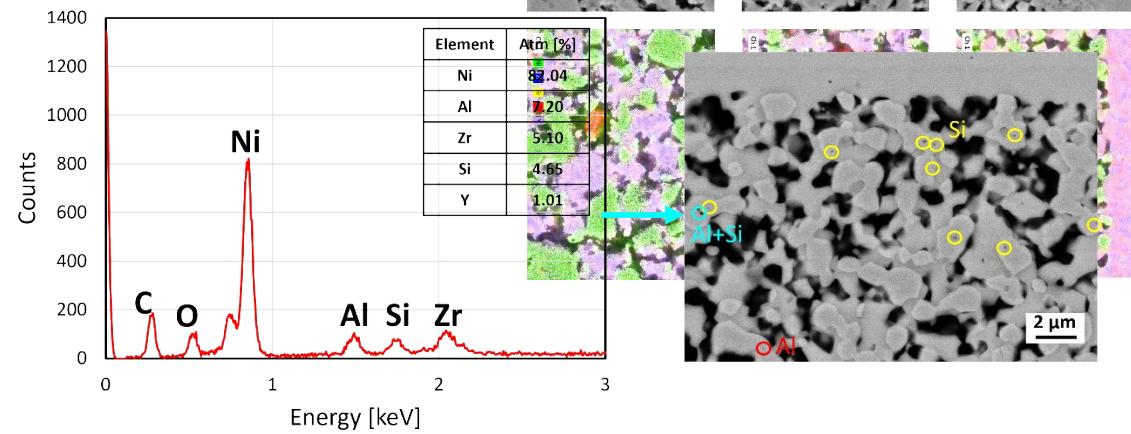
Figure S4. An example of EDX results of point analysis in Cell_B inlet at electrode/electrolyte interface, and the location is indicated on the SEM image.

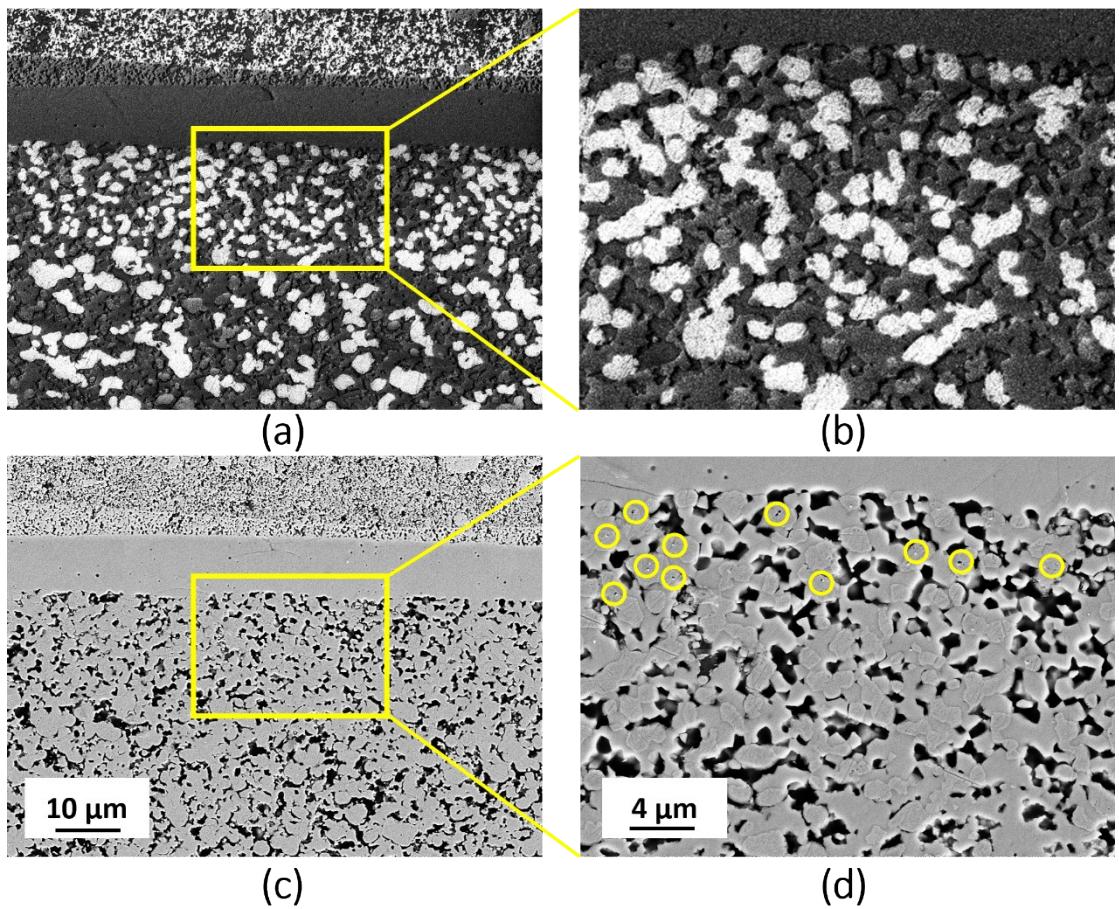
Figure S5. Comparison of percolated Ni images (a-b) and SE2 images (c-d). (b) and (d) are magnified views of (a) and (c), respectively. Yellow circles in (d) indicate locations where Si was detected by EDX analysis.

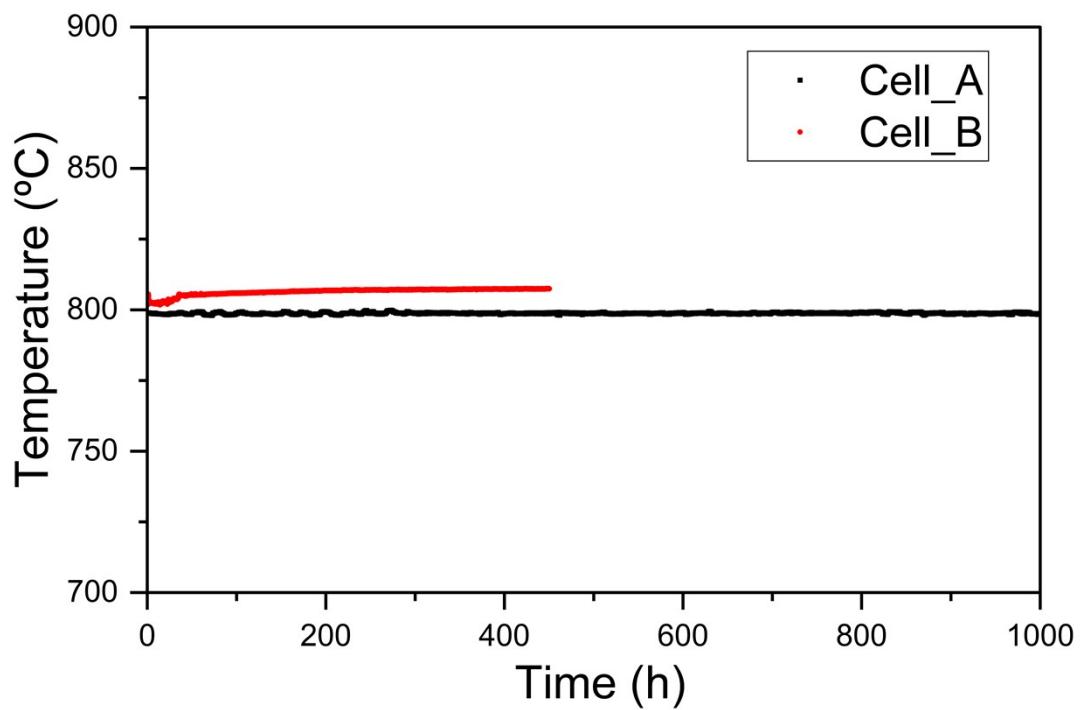
Figure S6. Operation temperature of Cell_A and Cell_B throughout the degradation tests.
