## Supporting Information

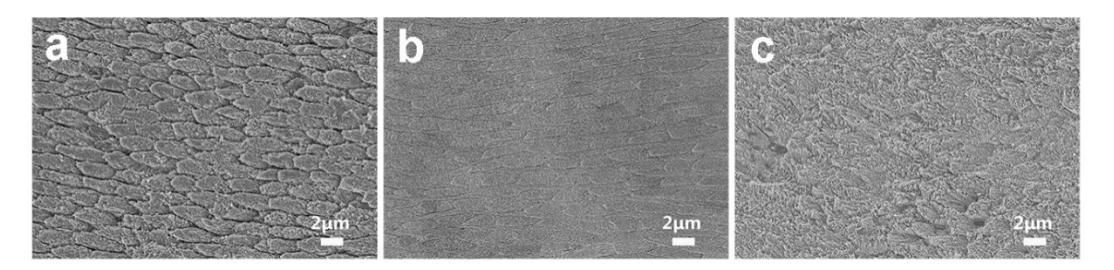
**Fig. S1** Low magnification images of enamel-like hydroxyapatite layer grown on acid etched enamel. a) enamel after acid etching; b) surface morphology of the acid etched enamel after the E125 treatment and re-mineralization in SOF for 12 h. c) surface morphology of the acid etched enamel after the Glu treatment and re-mineralization in SOF for 12 h.

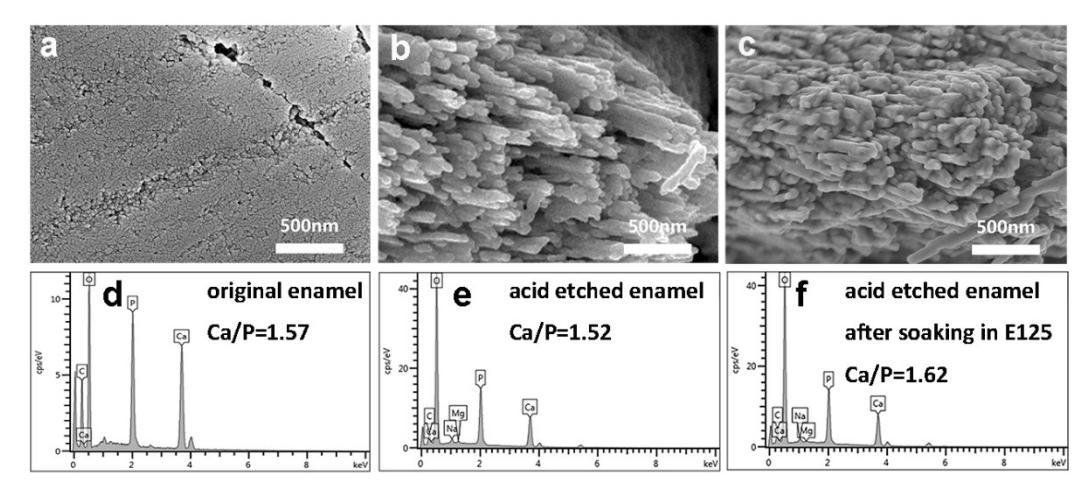
**Fig. S2** SEM images and EDS data of enamel surface. a) original enamel; b) enamel after acid etching; c) acid etched enamel after soaking in 1% E125 solution for 24 hours. (d), (e) and (f) are the EDS analysis data of (a), (b) and (c) respectively.

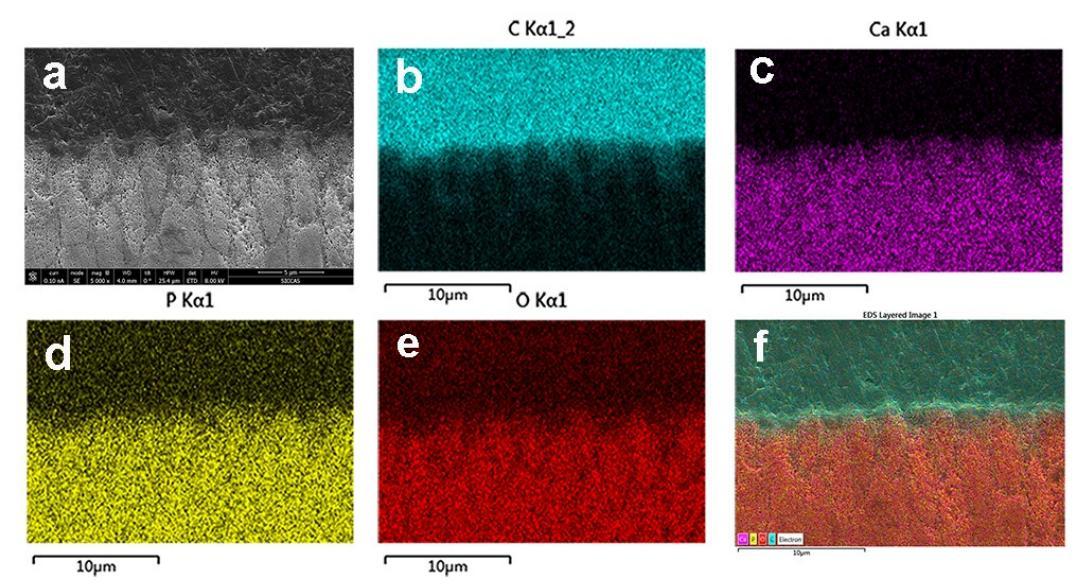
**Fig. S3** EDS mapping results of the cross section of the re-mineralized enamel infiltrated with dental resin. a): SEM image of the microstructure of cross section of the re-mineralized enamel infiltrated with dental resin; b) C element mapping (blue color); c) Ca element mapping (purple color) ; d) O element mapping (red color); e) P element mapping (yellow color); f) The overlay image of all element mappings. The blue area represents C element mapping, indicating the distribution of dental resin. The orange color in (F) represents the overlay image of Ca, P, and O element mappings indicating the calcium phosphate mineral region. It is clear to see that the blue color penetrates into the orange area, which indicates the well infiltration of dental resin in the re-mineralized enamel structure.

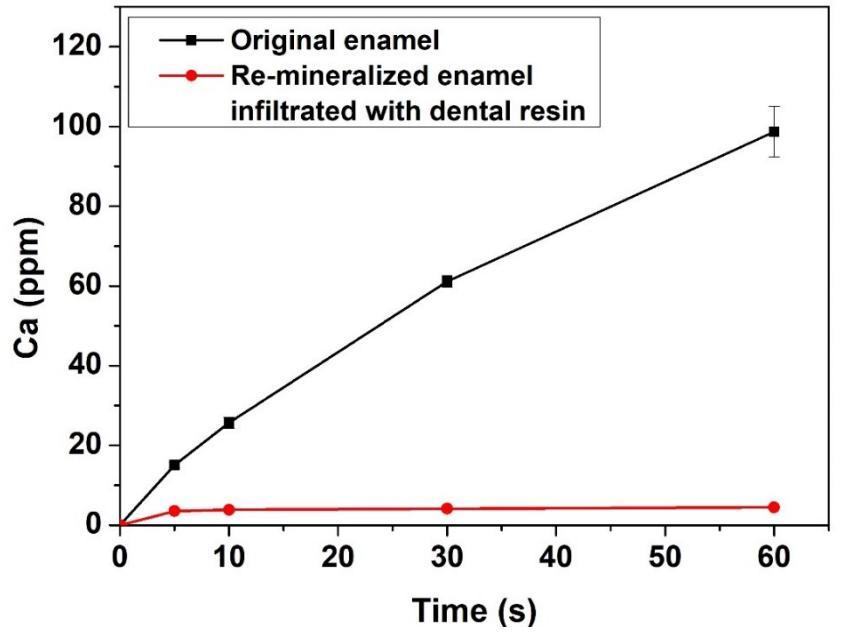
**Fig. S4** The Ca<sup>2+</sup> concentrations of original enamel and re-mineralized and resin infiltrated enamel after soaking in phosphoric acid.

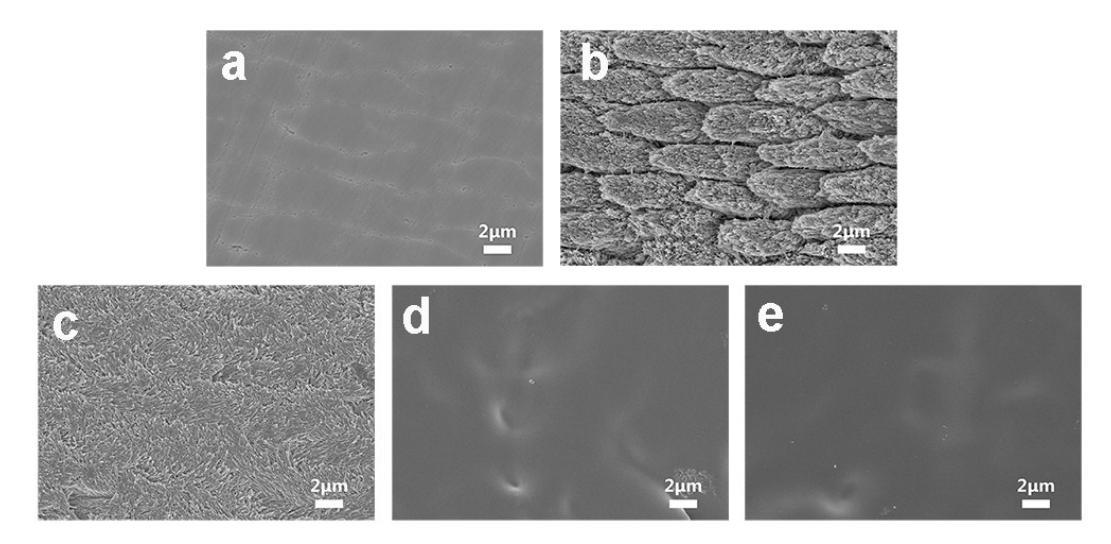
**Fig.S5** SEM images of the samples to resist acid erosion. a) the original enamel; b) the original enamel after phosphoric acid etching for 1 min; c) the re-mineralized enamel; d) the re-mineralized enamel infiltrated with dental resin; e) the re-mineralized enamel infiltrated with dental resin; e) the re-mineralized enamel infiltrated with dental resin; and then phosphoric acid etched for 1 min.
