Supporting Information

Relation between Work Function and Structural Properties of Triangular Defect in 4H-SiC Epitaxial Layer: Kelvin Probe Force Microscopic and Spectroscopic Analyses

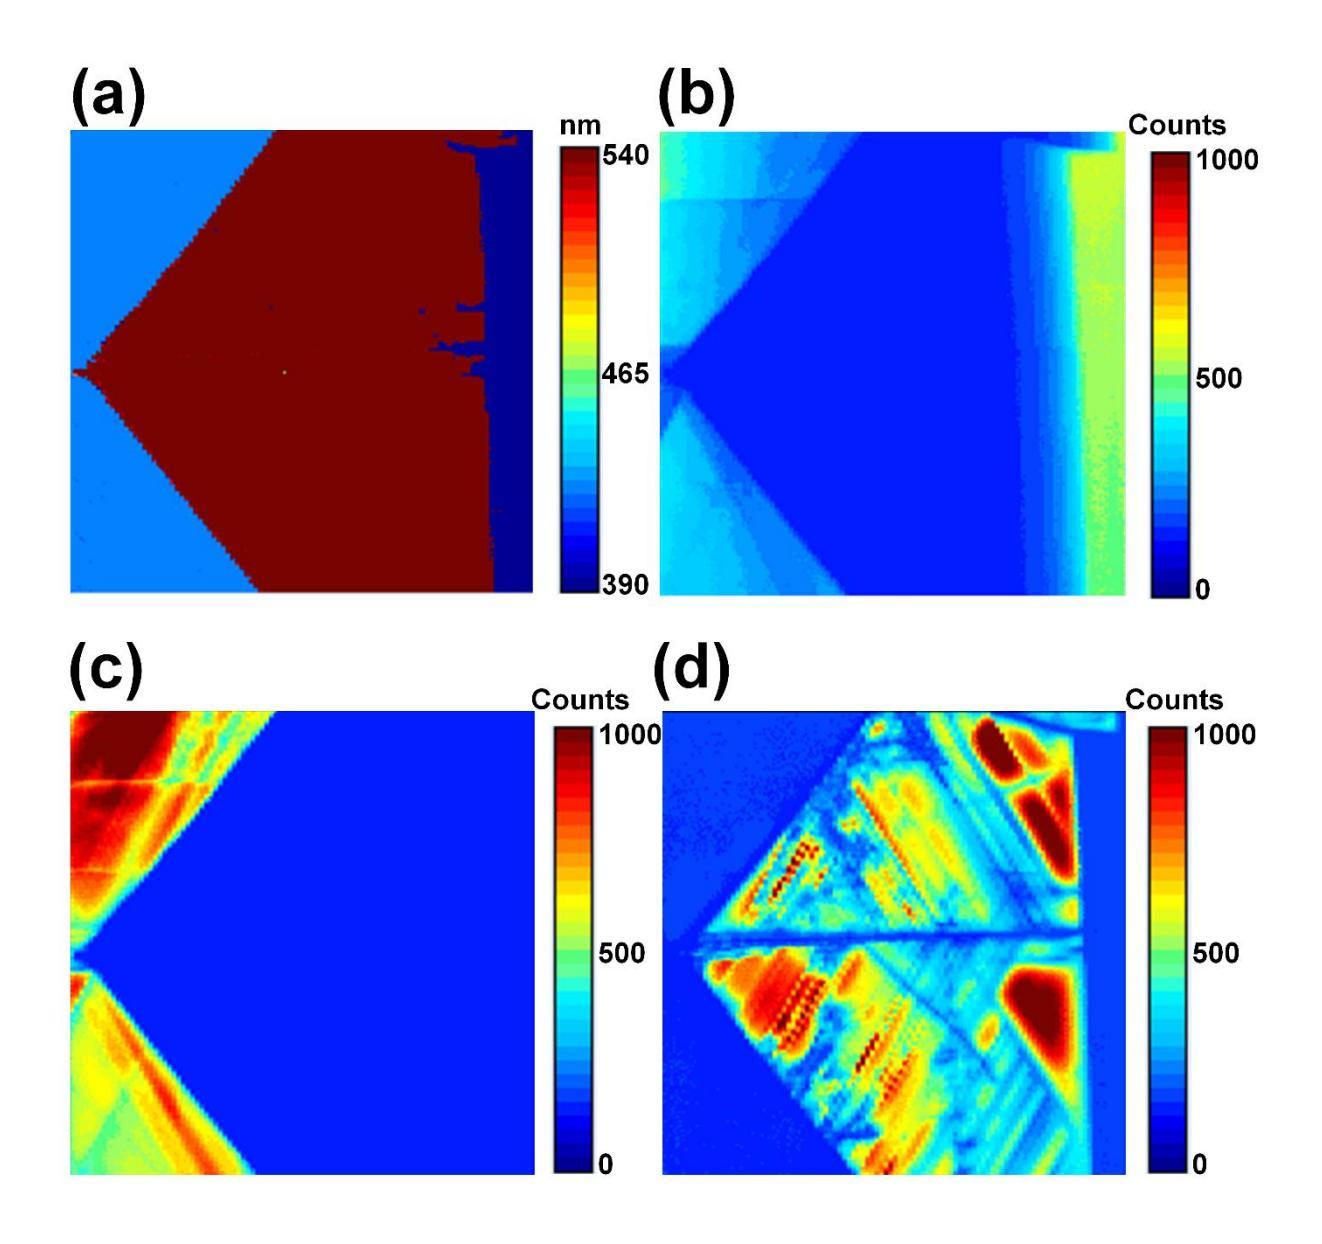
Fig. S1. Photoluminescence (PL) measurement of the triangular defect. (a) PL wavelength mapping which has the highest intensity at each wavelength corresponding to the 4H-SiC (390 nm, navy), single Shockley stacking fault (424 nm, cyan), and 3C-SiC (540 nm, wine); the single Shockley stacking fault may be formed during the PL measurement due to the instable interface conditions. (b) PL intensity mapping image at 390 nm (navy). (c) PL intensity mapping image at 424 nm (cyan). (d) PL intensity mapping image at 540 nm (wine); the triangular defect had the 3C polytype and various structural defects.

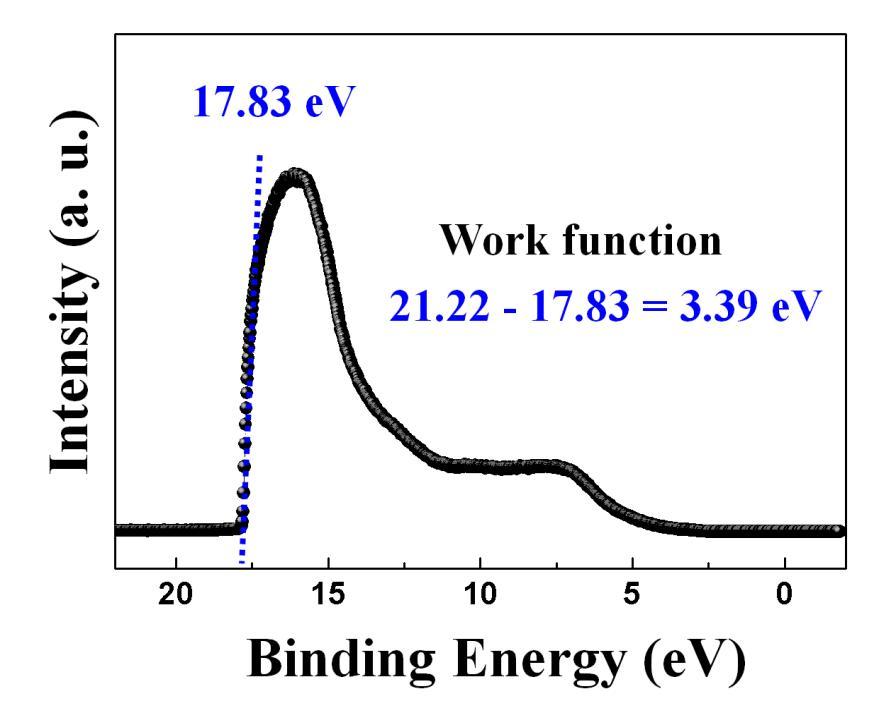
Fig. S2. Result of ultraviolet photoelectron spectroscopy (UPS) from the 4H-SiC epitaxial layer

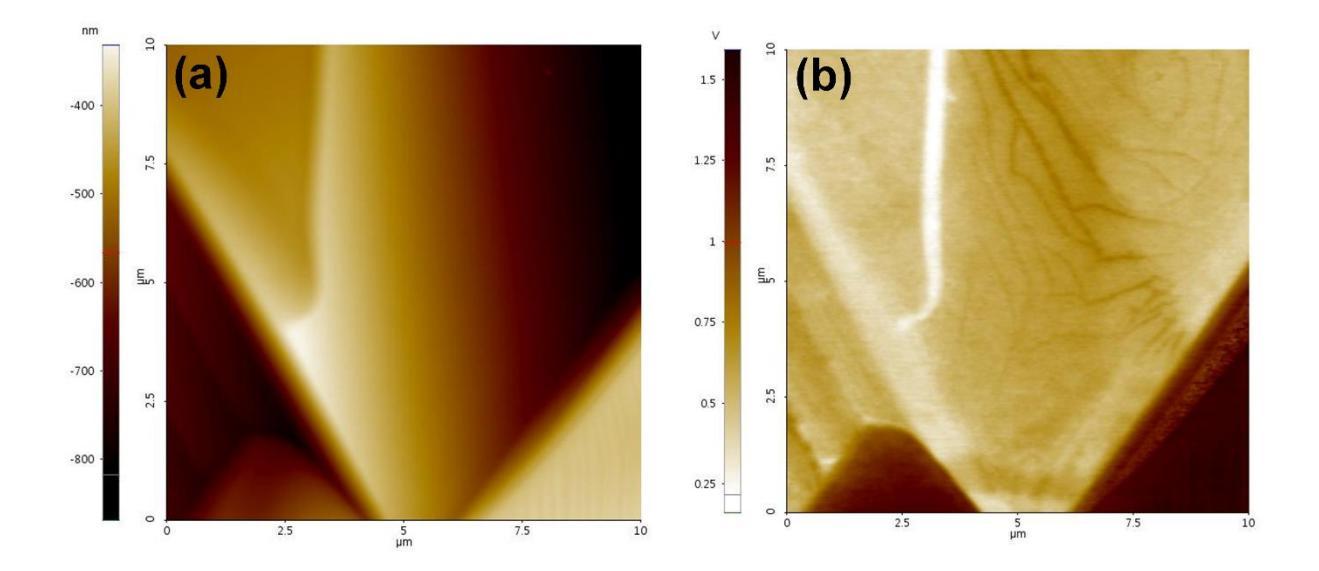
Fig. S3. Enlarged (a) topographic and (b) surface potential images at the vicinal face showing the disordered terraces.

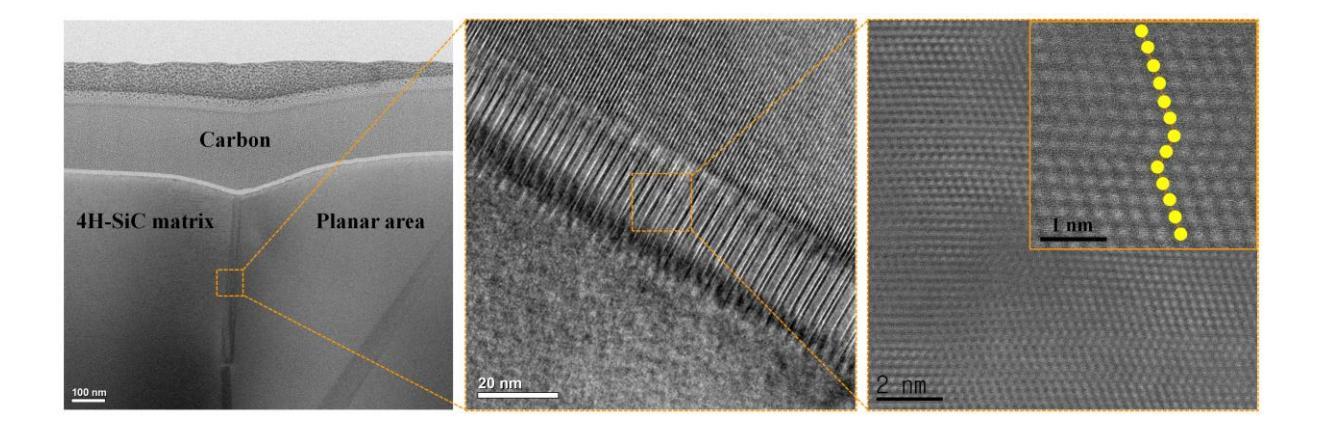
Fig. S4. High-resolution (scanning) transmission electron microscopy (HR(S)TEM) images for the stacking faults at the interface between the 4H-SiC matrix and the triangular defect.
