# Classification of High-Ni NCA/Gr-Si Commercial Cells before Rapid Capacity Drop by Diagnosing the Heterogeneous Degradation

## **Supporting Information**

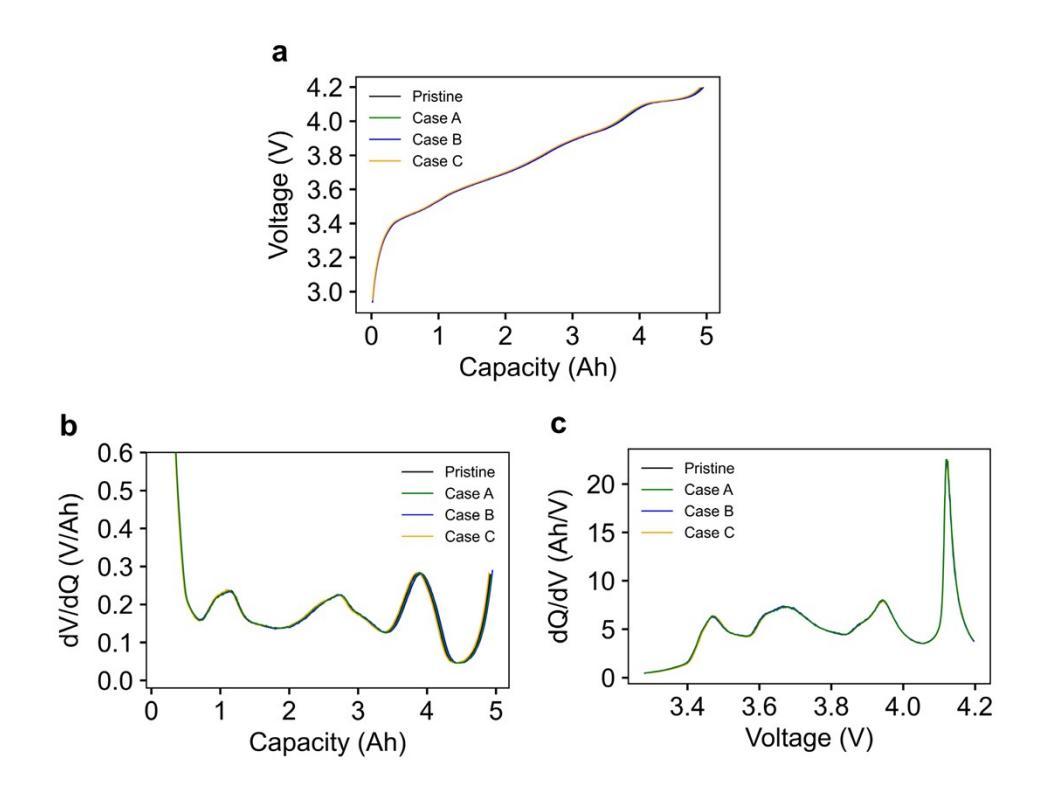
**Fig. S1** Inspection by non-destructive analysis in the pristine state: Each case has an overlapped (a) voltage curve, (b) DV curve, and (c) IC curve, showing that they were in uniform states before operation.

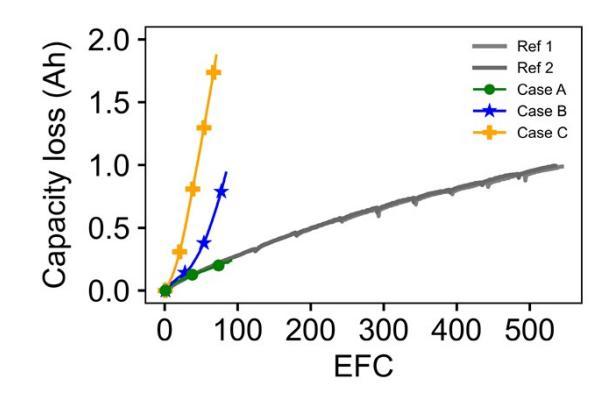
**Fig. S2** Comparison of the cycle performance (under 1C/1.25C DOD100% at  $45^{\circ}$ C) between reference cells and degraded cells. Case A followed the capacity loss of reference cells, but Cases B and C showed rapid capacity drops.

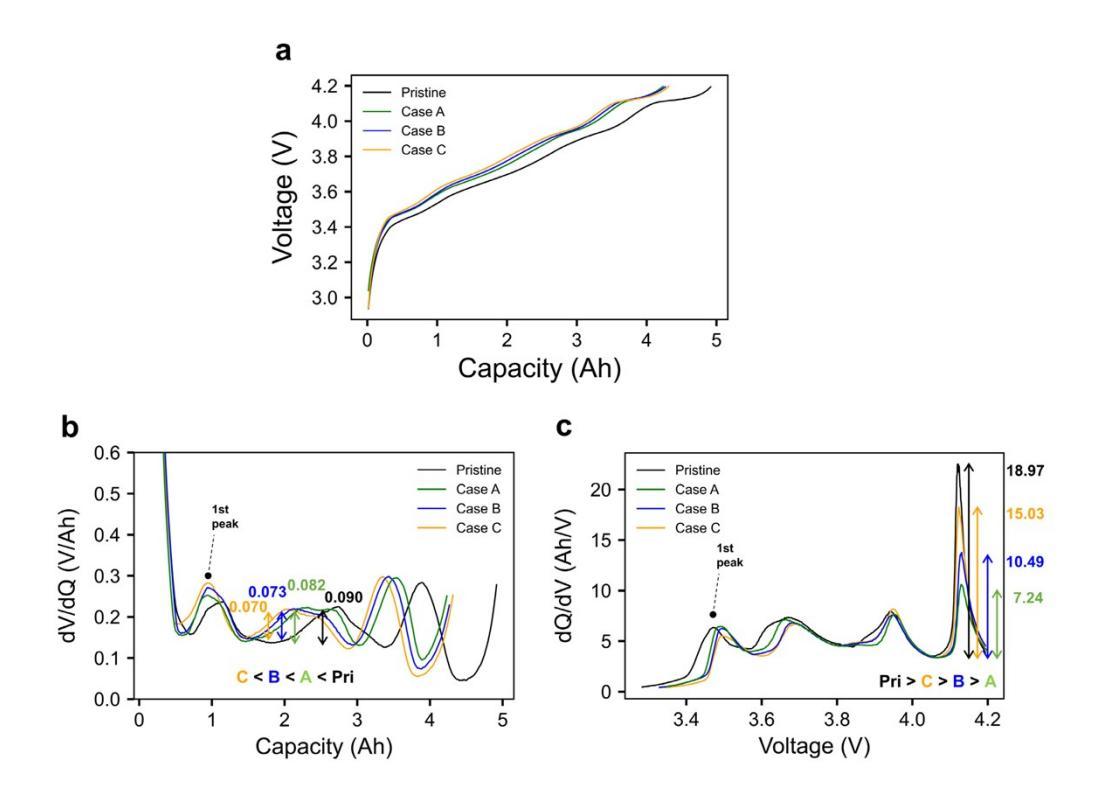
**Fig. S3** Inspection by non-destructive analysis after the first operation: (a) Different shapes of voltage curves despite similar capacity levels. (b) Comparison of features on the second peak of the DV curve that showed a decreasing tendency in the order of severe capacity loss during the second operation. (c) Comparison of features on the fourth peak of the IC curve that showed a decreasing tendency in the order of mild capacity loss during the second operation.

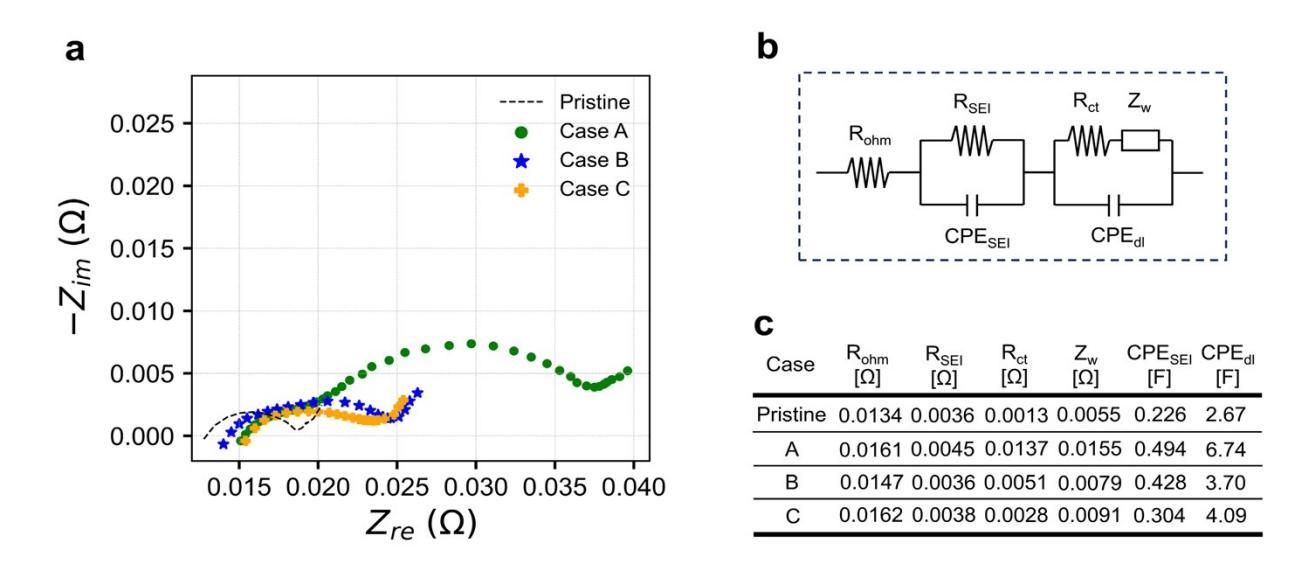
**Fig. S4** Resistance growth after the first operation: (a) Nyquist plots of each case from EIS measurement. (b) Equivalent circuit model based on the second order Randles circuit for the quantification of each element in the Nyquist plot. (c) The result table of quantified elements with a significant growth of  $R_{ct}$  in Case A but less growth of  $R_{ct}$  in Cases B and C.

during the occurrence of lithium plating on the anode surface.<sup>7</sup> Thus, the growth of  $R_{ct}$  was utilized for the comparison of cathode degradation.

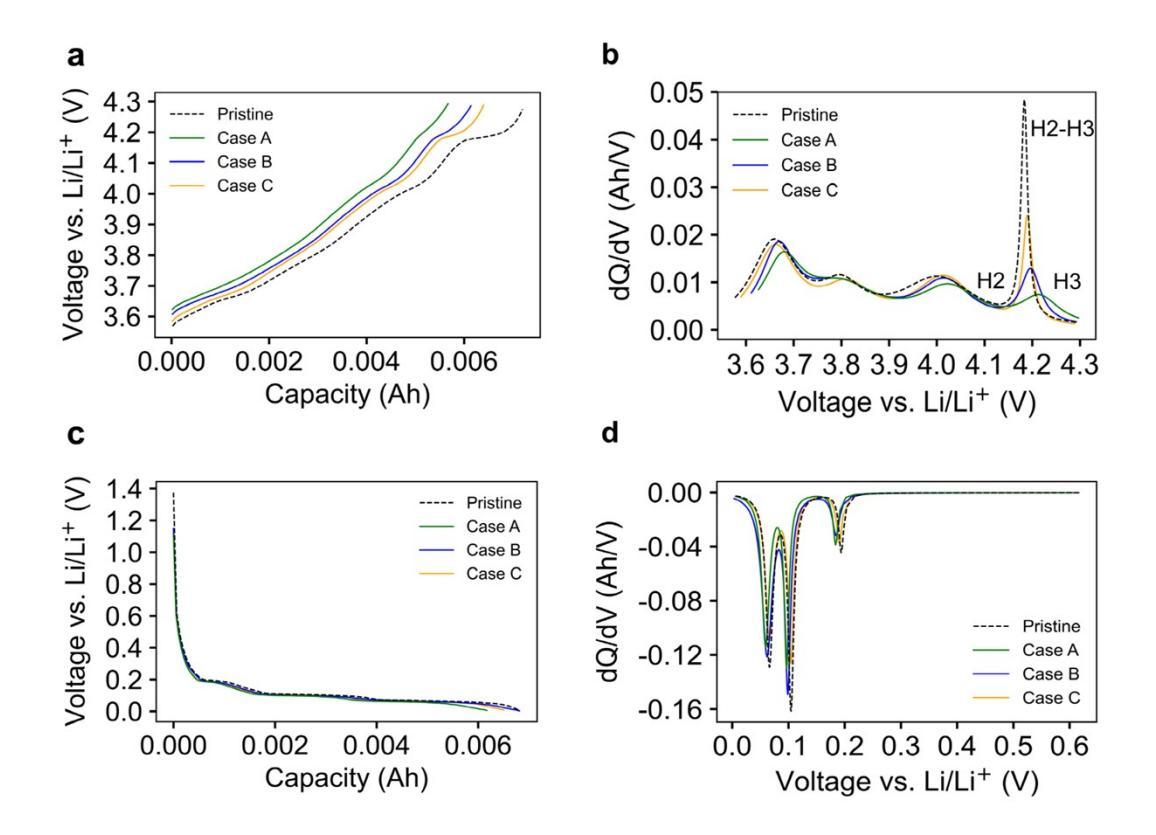
**Fig. S5** Electrode half-cell test to approach the voltage curve deformation of the aged cell: (a) Cathode voltage curves in each case sequentially showing the capacity loss, and (b) cathode IC curves with the variation of peak height in the H2-H3 phase exhibiting the loss of cathode active materials. (c) Anode voltage curves in each case without distinct capacity loss, and (d) the anode IC curves with little deformation.

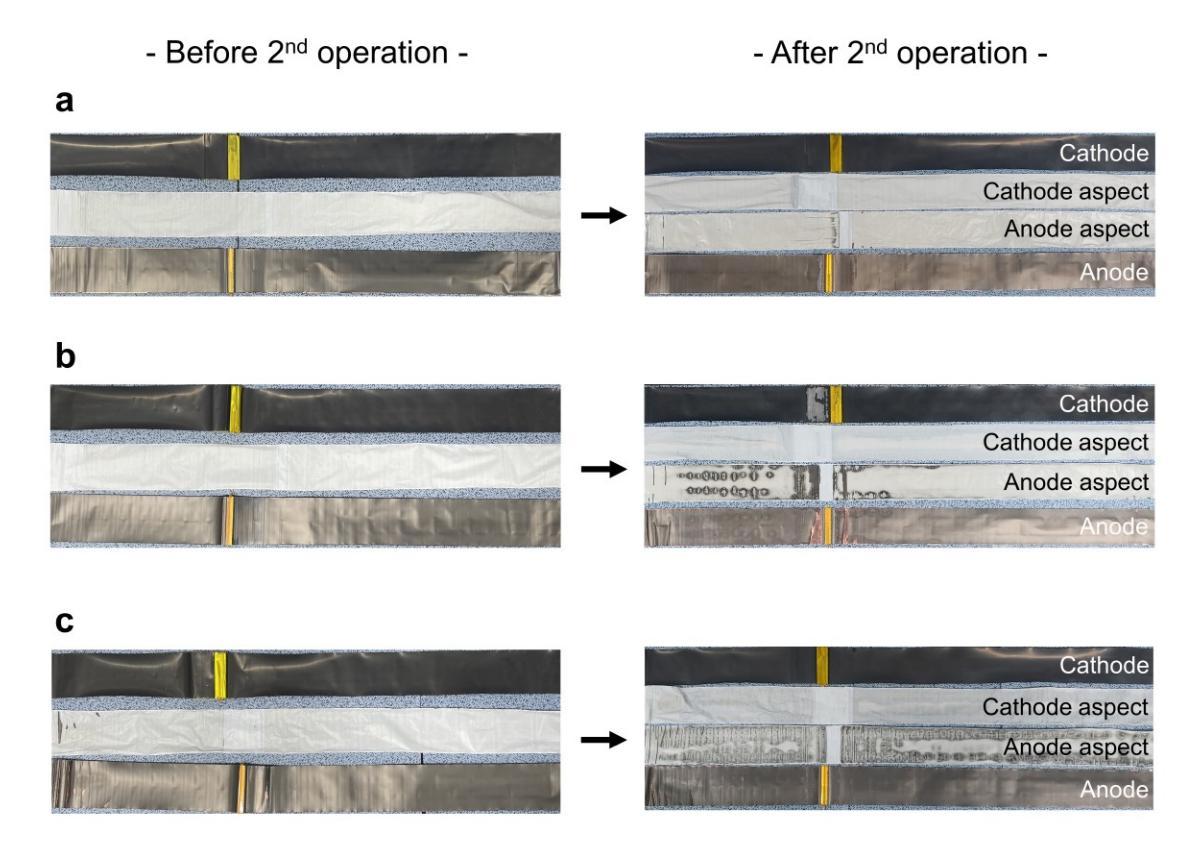
**Fig. S6** Each electrode and separator after disassembly: (a) Case A with ordinary exteriors before and after the second operation. (b) Case B with anode exfoliation at the core region after the rapid capacity drop in the second operation. (c) Case C with anode exfoliation in the overall region after the most severe capacity drop in the second operation.

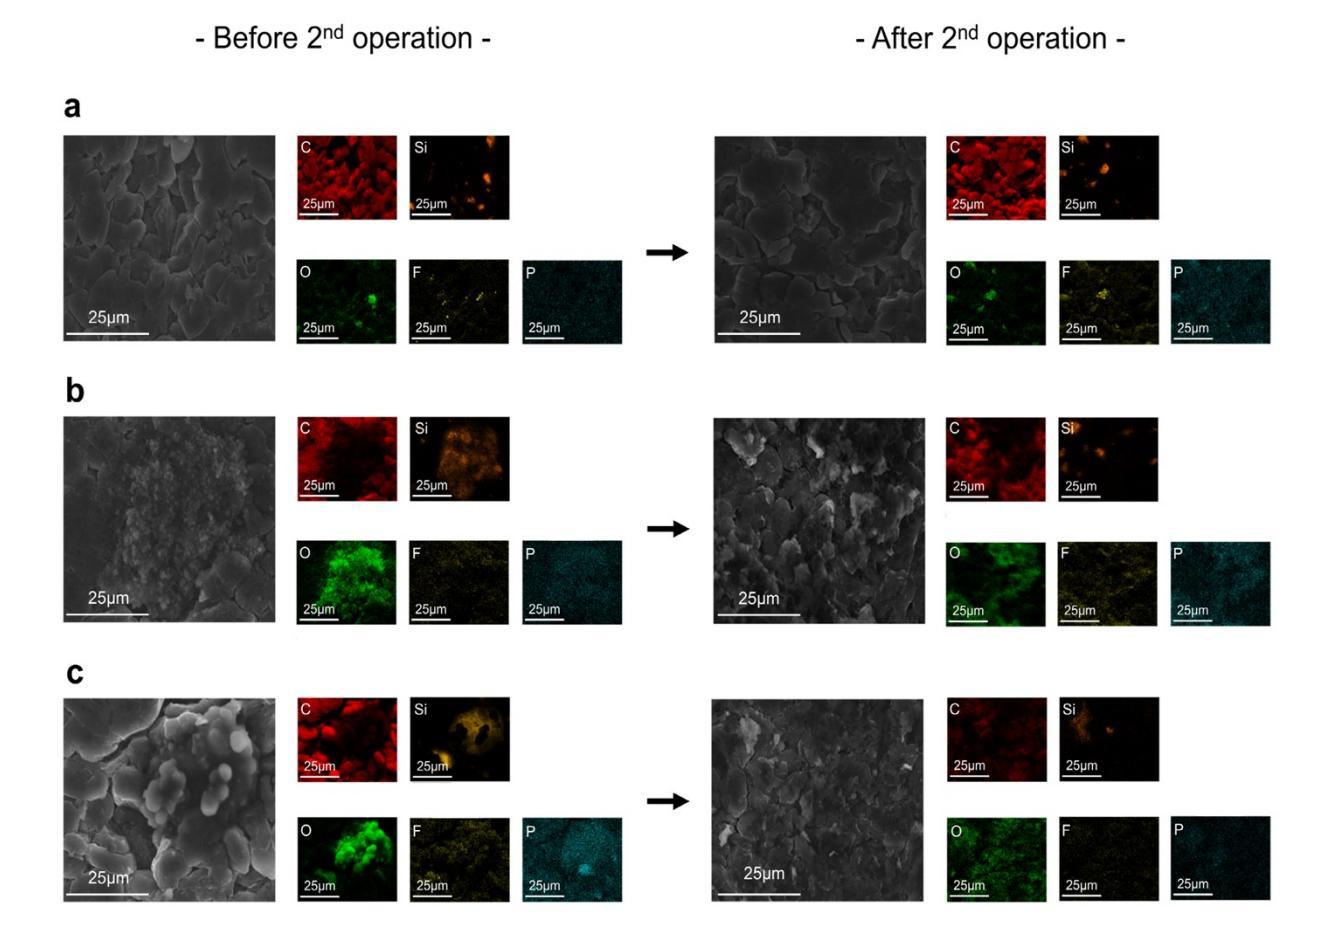
**Fig. S7** Morphology of each cell anode from SEM-EDS analysis (red – C, orange – Si, green – O, yellow – F, cyan – P): (a) Anode morphologies in Case A without distinct deformation during entire operations. (b) Anode morphologies in Case B with pulverized Si compound clogging the porous structure before the second operation and with mossy-like lithium plating after the second operation. (c) Anode morphologies in Case C with the expanded Si compound before the second operation and with mossy-like lithium plating after the second operation.

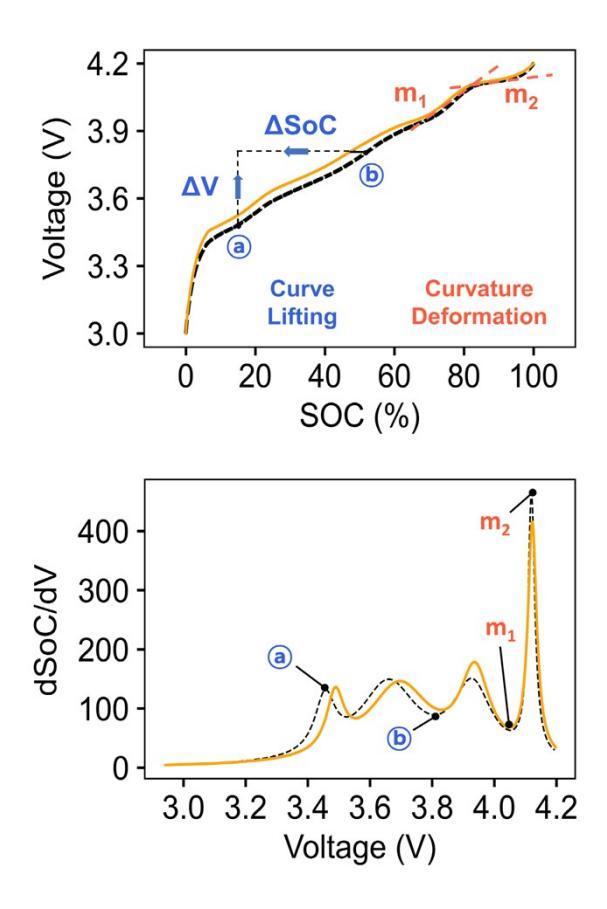
**Fig. S8** Illustration of feature extraction. Curvature deformation in the H2-H3 phase (around 4.1V) and curve lifting factors in the low voltage range (around 3.5-3.8V) would be extracted by using the features based on the characteristic points on the IC curve (bottom).

In order to automatically determine the characteristic points on the IC curve with a smoothing process, the Lorentzian function-based fitting method was employed using the nonlinear least squares algorithm in the Scipy package of Python.<sup>12</sup> The characteristic points of a pristine state were measured from the mean value of 100 cells in their pristine state. Based on these points of pristine state, features from degraded cells were extracted following the suggested equations to represent the curvature deformation and curve lifting factors. The Gompertz model consists of the asymptote ( $\theta_1$ ), x-axis displacement ( $\theta_2$ ), and growth rate ( $\theta_3$ ) as parameters that determine the activation function for feature processing. This study employed the parameter values as  $\theta_1 = 2$ ,  $\theta_2 = 3$ , and  $\theta_3 = 0.632$ .

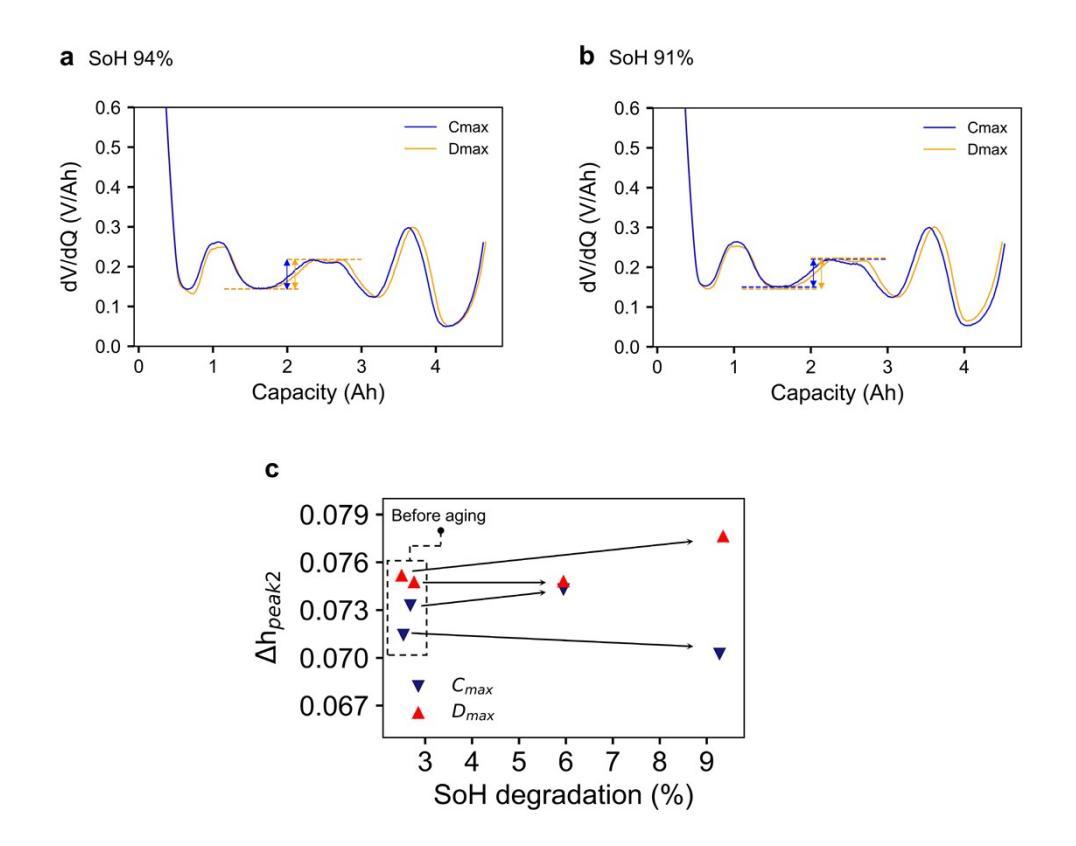
**Fig. S9** Diagnosis by the DV curve analysis: The comparison of a feature on the second DV peak ( $\Delta$ h within the dashed lines) at (a) SoH 94% and (b) SoH 91% levels. (c) Plot of feature values that cause confusion for the classification of degradation paths due to the poor resolution.

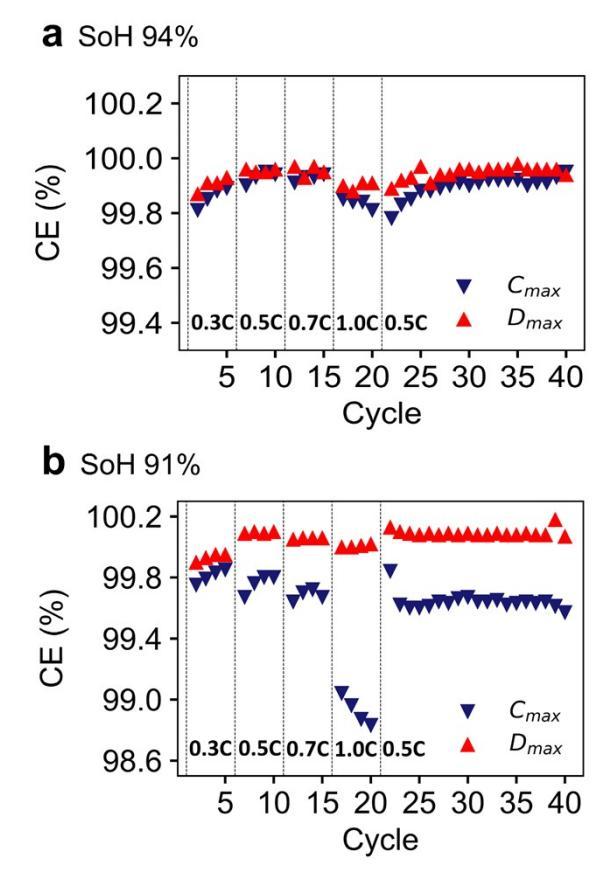
**Fig. S10** Coulombic efficiency (CE) during the rate capability test: (a) The comparison of CE between  $C_{max}$  and  $D_{max}$  cases collected at SoH 94% (average CE for  $C_{max, 94}$  vs.  $D_{max, 94}$  / 0.3C: 99.86% vs. 99.91%; 0.5C: 99.93% vs. 99.96%; 0.7C: 99.93% vs. 99.96%; 1.0C: 99.84% vs. 99.90%; 0.5C duration: 99.90% vs. 99.95%). (b) The comparison of CE between  $C_{max}$  and  $D_{max}$  cases collected at SoH 91% (average CE for  $C_{max, 91}$  vs.  $D_{max, 91}$  / 0.3C: 99.81% vs. 99.93%; 0.5C: 99.76% vs. 100.1%; 0.7C: 99.68% vs. 100.06%; 1.0C: 98.93% vs. 100.01%; 0.5C duration: 99.64% vs. 100.09%).

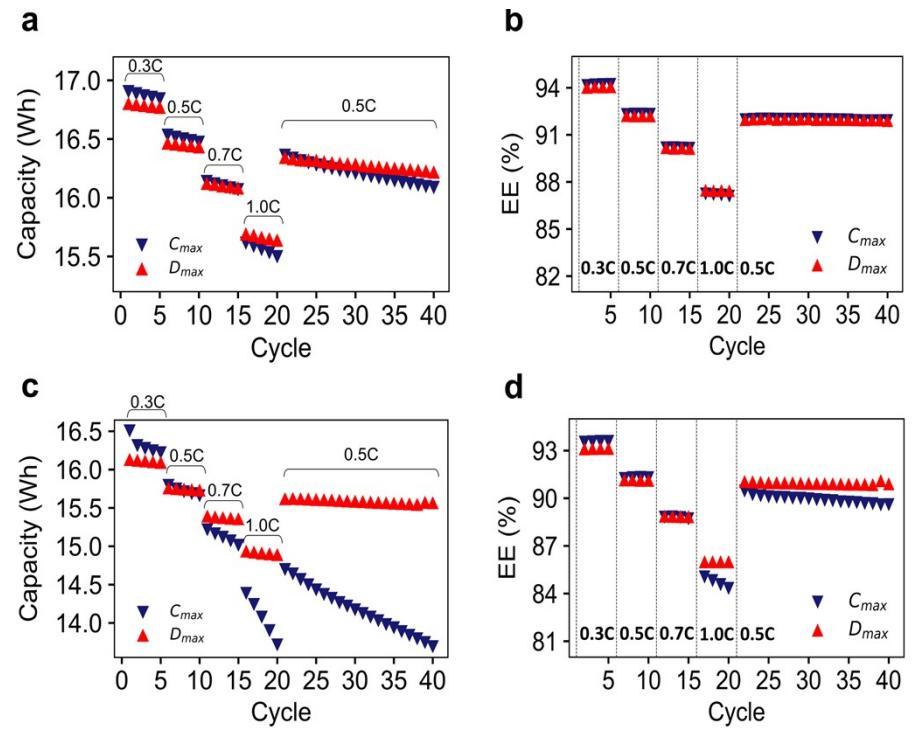
**Fig. S11** The result of the rate capability test from the energy (Wh) perspective: (a) Wh-capacity and (b) energy efficiency (EE, Wh<sub>dis</sub>/Wh<sub>ch</sub>) of C<sub>max</sub> and D<sub>max</sub> cases collected at SoH 94% (average EE for C<sub>max, 94</sub> vs. D<sub>max, 94</sub> / 0.3C: 94.19% vs. 94.05%; 0.5C: 92.32% vs. 92.21%; 0.7C: 90.17% vs. 90.15%; 1.0C: 87.18% vs. 87.45%; 0.5C duration: 91.97% vs. 91.98%). (c) Wh-capacity and (d) EE of C<sub>max</sub> and D<sub>max</sub> cases collected at SoH 91% (average EE for C<sub>max, 91</sub> vs. D<sub>max, 91</sub> / 0.3C: 93.57% vs 93.12%; 0.5C: 91.29% vs. 91.14%; 0.7C: 88.79% vs. 88.86%; 1.0C: 84.69% vs. 86.0%; 0.5C duration: 89.92% vs. 90.94%).

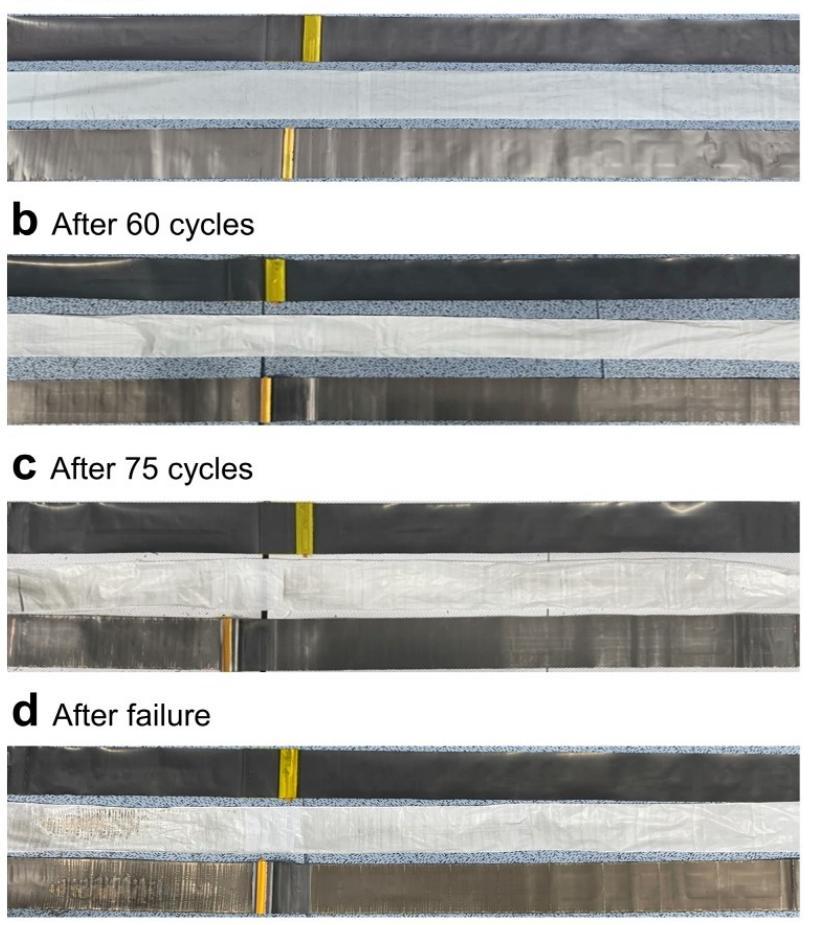
**Fig. S12** The observation of electrode surface variations from cells of the  $C_{max}$  case: The electrode surface without the lithium deposition in (a) Pristine and (b) after 60 cycles. The local lithium deposition in the core region (c) after 75 cycles and its aggravation (d) after failure.
