Supplementary Figures

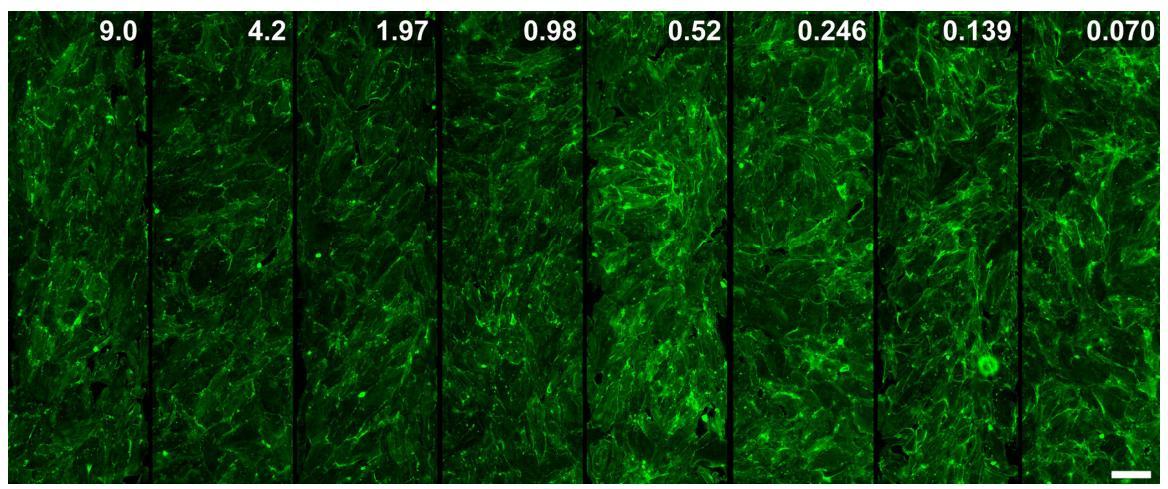
Figure S-1. Fluorescent micrographs of endothelial monolayer in test regions 1-8 (from right to left) after ~15 hours of perfusion in the microfluidic setup. The magnitudes of shear stress in dyn/cm² are shown in the upper right corners. Scale bar is 200 μ m. Actin filaments of endothelial cells were fluorescently labeled by staining with Alexa488-phalloidin, after the perfusion was stopped and the magnetic clump was disassembled. The staining protocol is described in detail in L. E. Goldfinger, E. Tzima, R. Stockton, W. B. Kiosses, K. Kinbara, E. Tkachenko, E. Gutierrez, A. Groisman, P. Nguyen, S. Chien and M. H. Ginsberg, *Circulation Research*, 2008, **103**, 177-185.

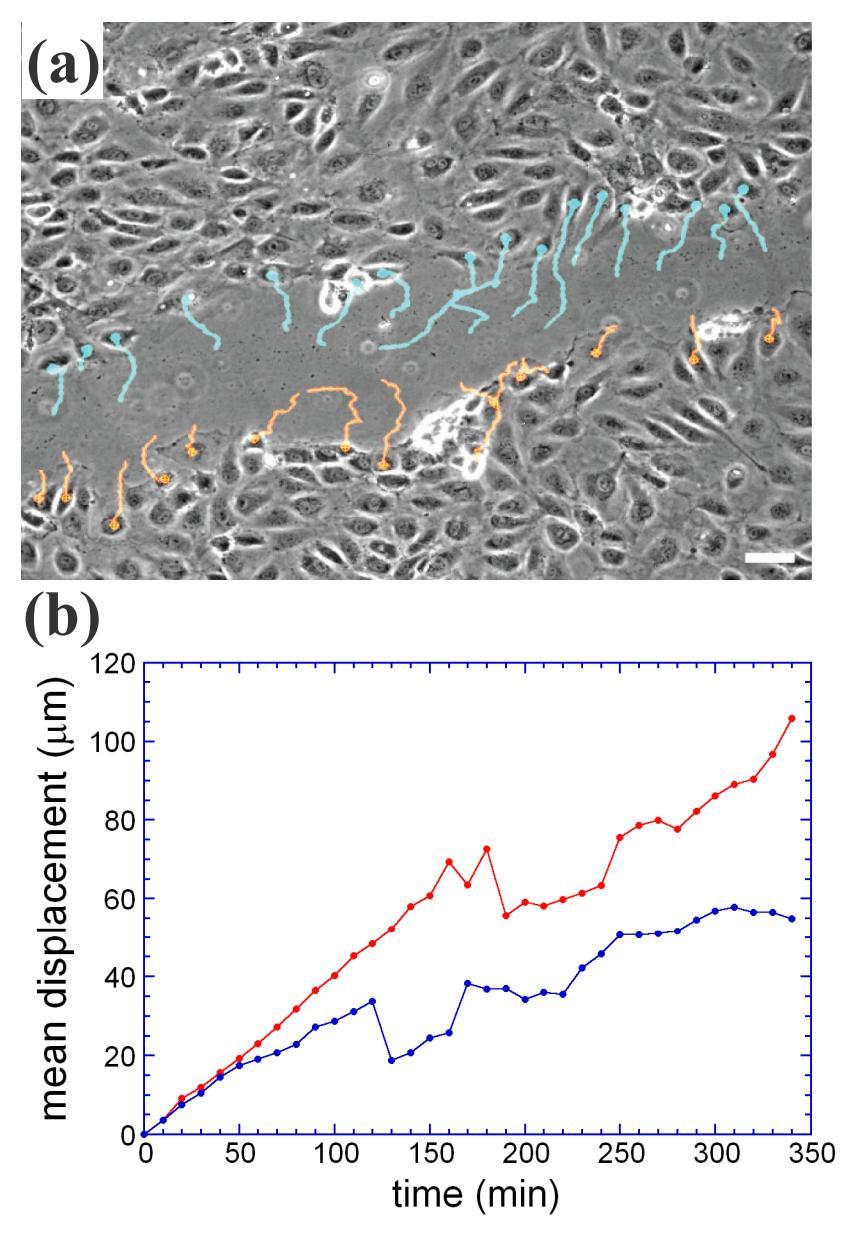
Figure S-2. Healing of a scratch wound in endothelium monolayer in the microfluidic device at a shear stress of 5 dyn/cm². (a) Micrograph of the original wound with superimposed tracks of migration of individual cells during the wound healing shown as blue and yellow curves. The flow direction is vertically down. Scale bar is 50 μ m. (b) Mean displacement along the direction of flow for cells migrating from the upstream edge (red curve) and from the downstream edge (blue curve) of the wound. Cells from the upstream and downstream edges migrated downstream and upstream, respectively. Linear fits to the curves give mean migration speeds of 18 and 11 μ m/hr, respectively. Cell tracking was performed with ImagePro 6.0 software (Media Cybernetics, Bethesda, MD) from a sequence of images taken every 10 min.
