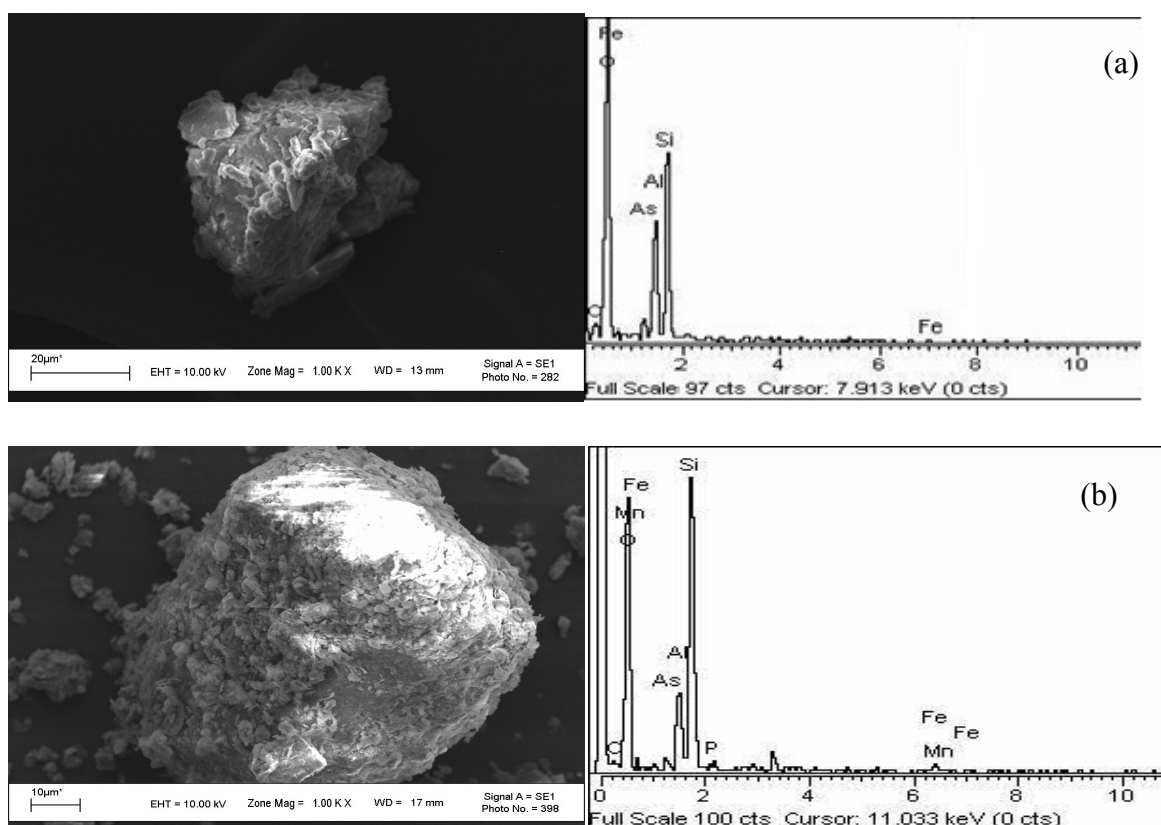
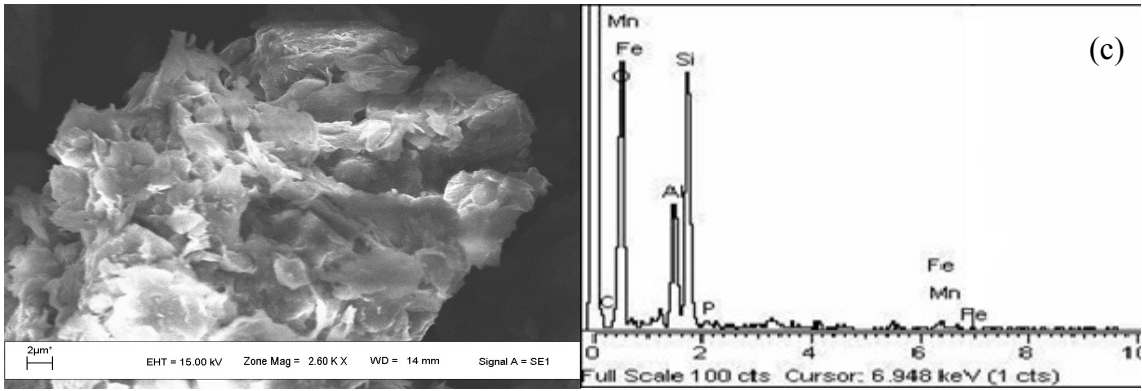
Figure A1. SEM and EDX of soil sediment samples (a) C\_50 (b) C\_70 (c) 1C\_150.

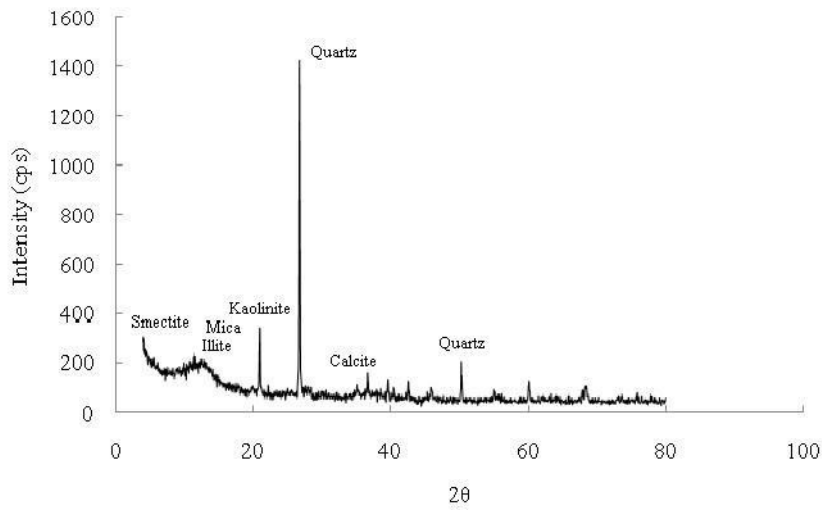
Figure A2. X-Ray Diffraction (XRD) of sediment samples (a) 1C\_50
