Supplementary figure

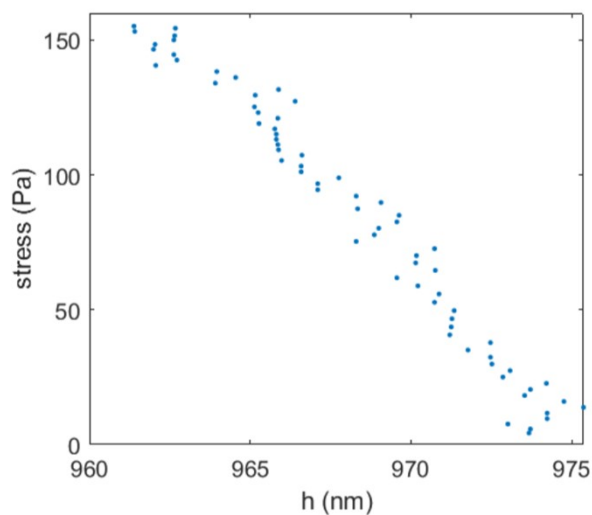
K50 (kPa)
Exp1	8.4
Exp2	7.3
Exp3	7.7
Exp4	9.7
Exp5	5.4

Left: Deformation as a function of applied stress of a reconstituted actin patch (from WT extract) which has grown under an applied stress of ~80 Pa. Right: Table of tangent modulus at 50 Pa of the patch on the left as well as four replicates on different patches grown under 80 Pa stress.
